MS MAGAZINE

**BIGGEST AFLOAT PROPULSION
REPAIR EVER MADE
PAGES 4 - 7**

BIGGEST AFLOAT PROPULSION REPAIR EVER MADE

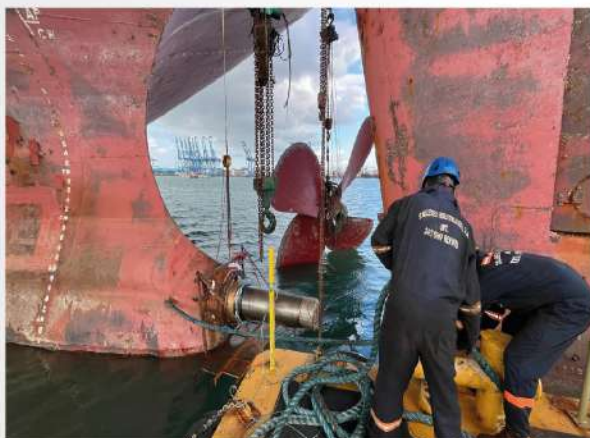
Removal of Propeller

Inside the engine room, we removed the intermediate shaft and bearing, and attempted to remove the tail shaft but then we realized it was jammed. Then identified that the tail shaft was damaged and could not come easily in any direction.

The first mission in this out-of-the-box repair which is always done at the dry dock was to trim the vessel with a Talleres pumping system and prepare the aft area for work.

Our team approached the vessel with a supply boat and barge loaded with equipment and installed a pair of 50-ton pneumatic chain hoists required to handle the 42-ton propeller.

We then, proceeded to remove the nut cap, released the nut, removed the propeller, and left hanging alongside.

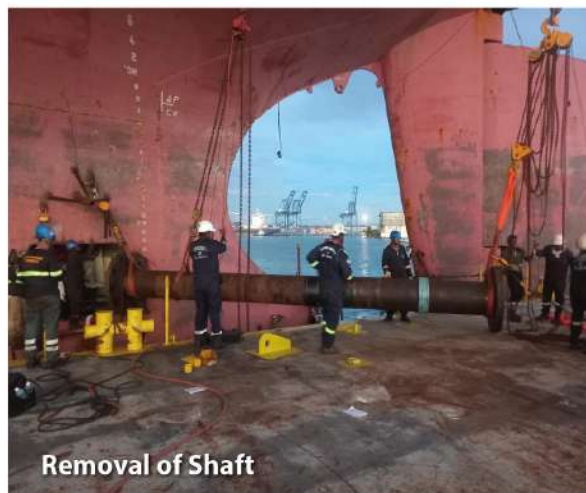
Removal of Stern Tube

Talleres fabricated a structure to pull the forward end of the tail shaft with 2 jacks of 500 tons but it was not possible to remove the shaft, we concluded that the forward end of the tail shaft was seized to the stern tube so we decided to cut the forward end of the shaft with the flange to take the complete stern tube with the forward end of the damage tail shaft pulled aft through the stern casting.
