# TALLERES INDUSTRIALES, S.A.

24/7 SHIP REPAIRS AND MARINE SOLUTIONS

MAGAZINE

Edition 12th

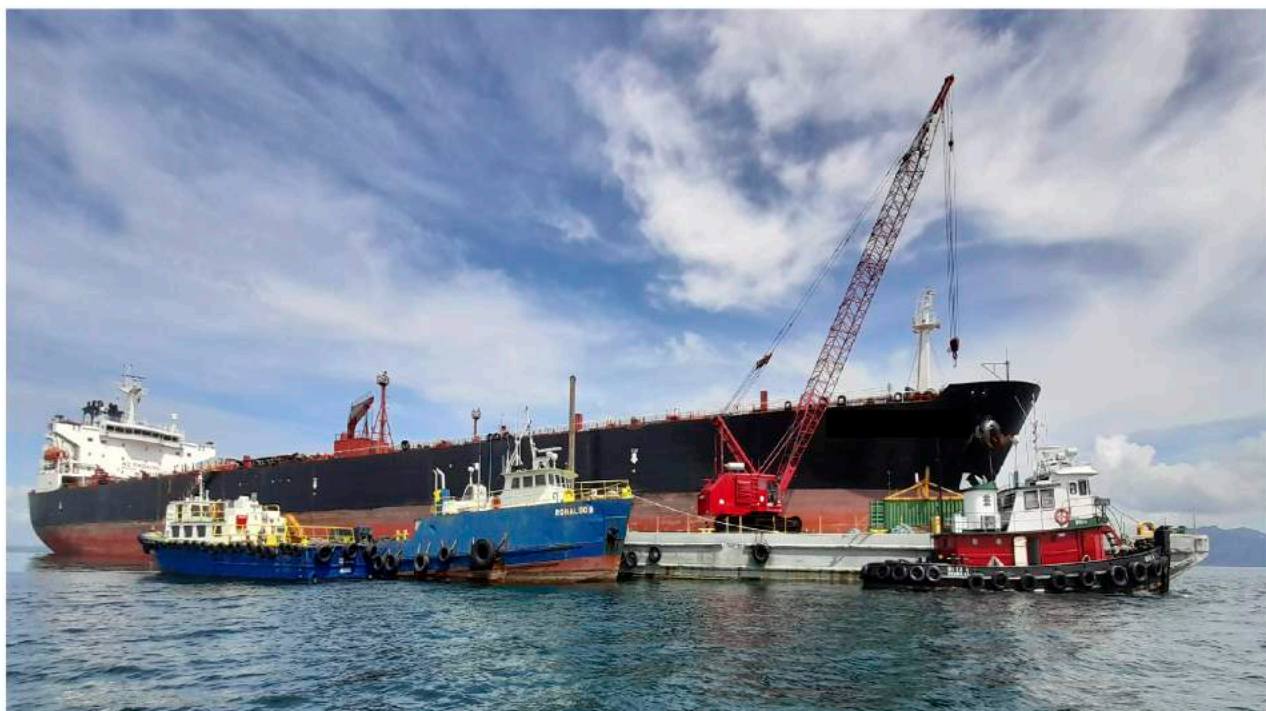
A ship management company from Europe reported a problem on the starboard windlass of one of their Panamax chemical tankers. Crew had opened the gear box for inspection and then found bearing sediments in the oil tank. These symptoms could have many root causes, so a deep inspection and repair needed to be done on short notice.

Mission was to expedite for all works to ensure vessel is ready for re-employment asap. Immediately after arrival to Balboa anchorage, Talleres arranged a team of mechanics and riggers to dismantle the windlass and remove it with the use of a floating crane barge. Complete unit was brought to our workshop for proper inspections and repairs.

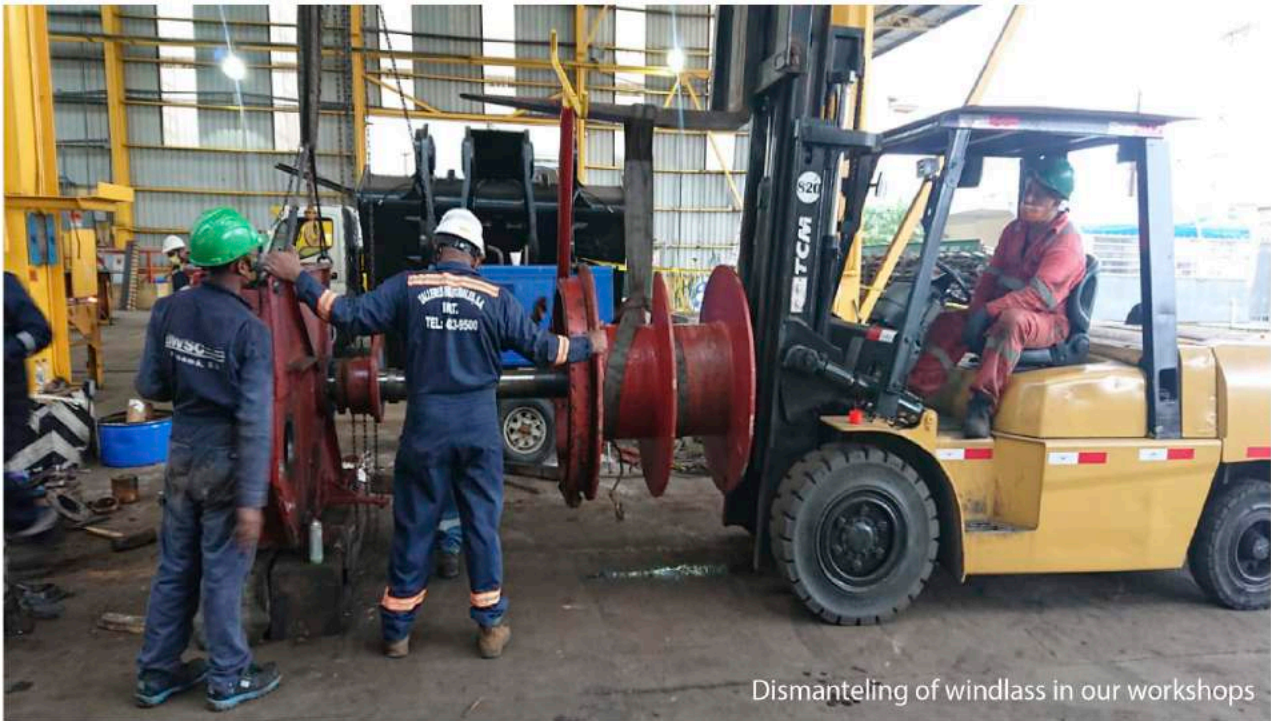
Dismantling of windlass in our workshops

The windlass was transferred ashore in our supply boat. Once in the workshop, our mechanics team separated the gearbox from the windlass with special tools. Shaft and guide pins were found damaged and had to be skimmed and fabricated on our machining workshop.

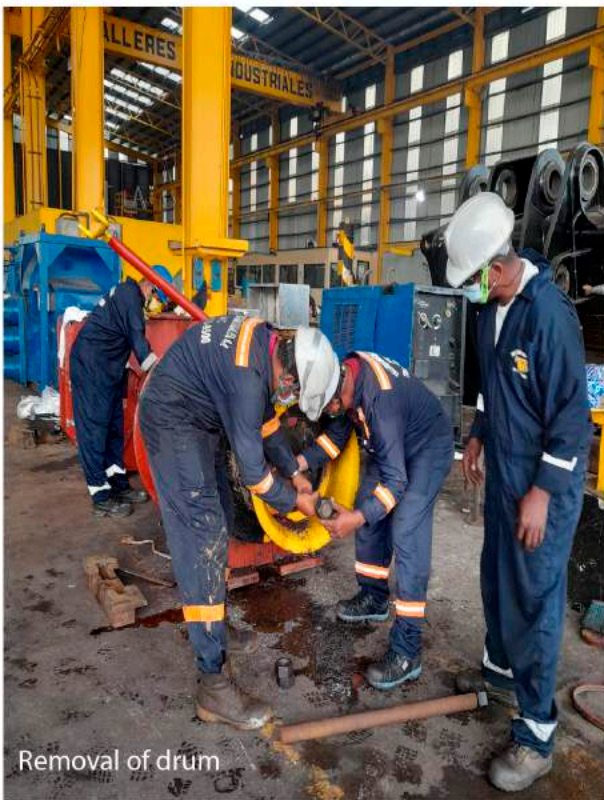
Removal of drum

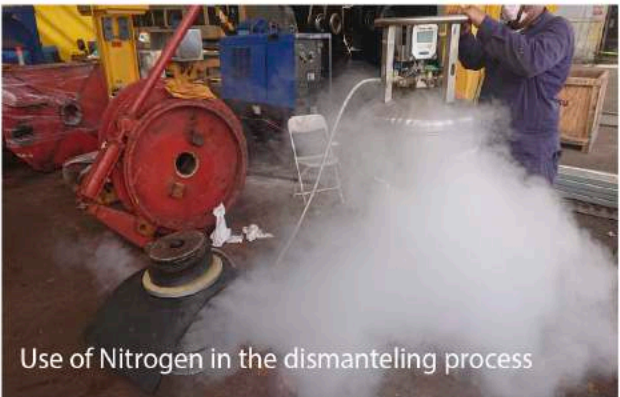
Use of Nitrogen in the dismantling process

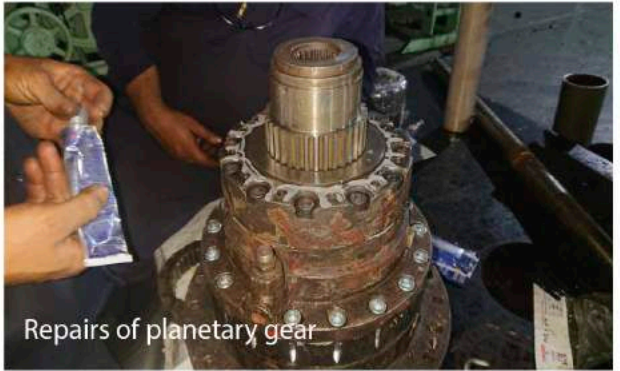
Repairs of planetary gear

Planetary unit needed to be repaired and bolts, seals, and bearings were also replaced. Windlass was assembled during the weekend; crane barge was once again in action to deliver and install in position but this time facing adverse weather conditions.

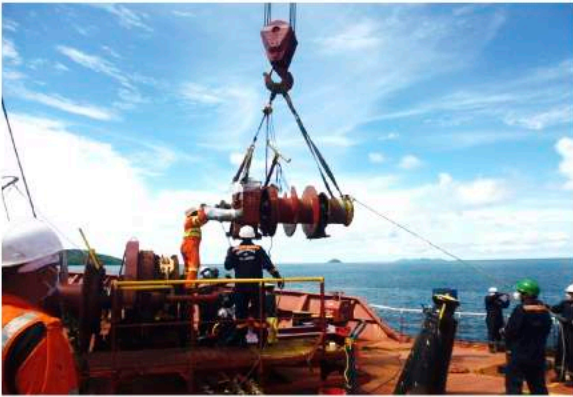
In addition, damaged brass bushings needed to be fabricated. Gearbox was inspected and oil was removed and renewed.

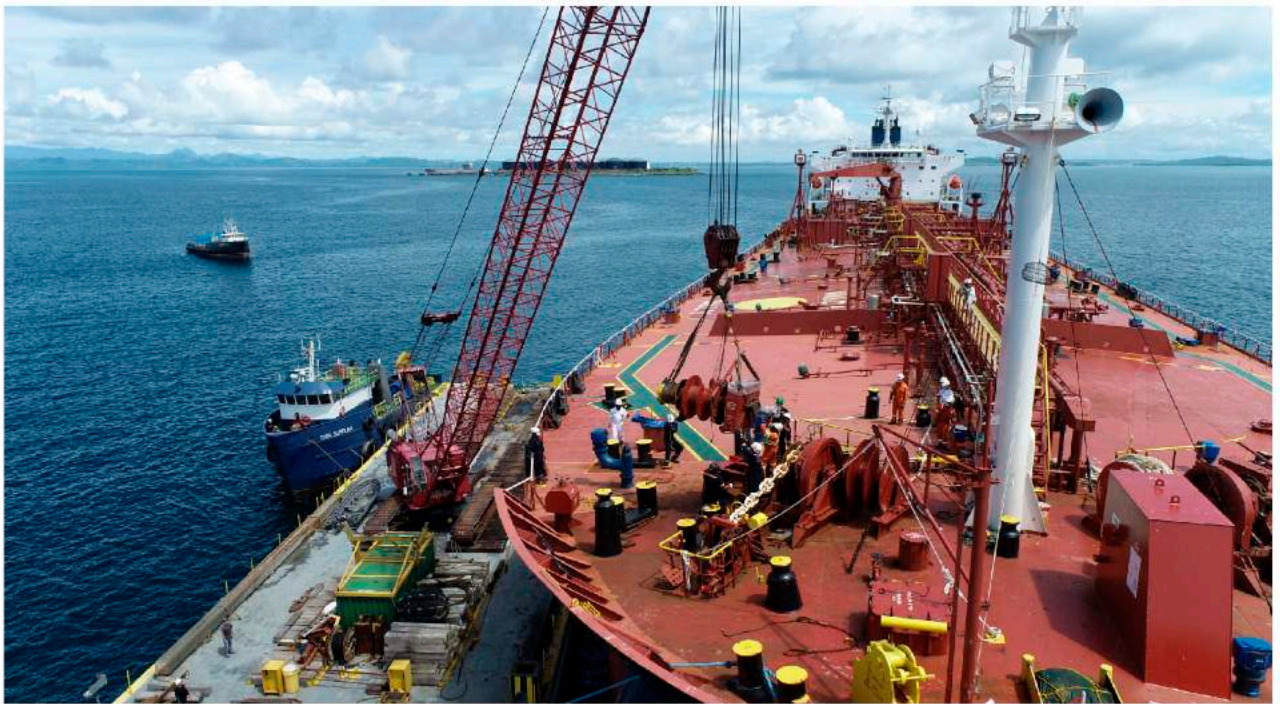
Windlass was installed and tested. Then some adjustments were done, and job was finally completed. No matter how complex a job seems to be, we make it look simple.

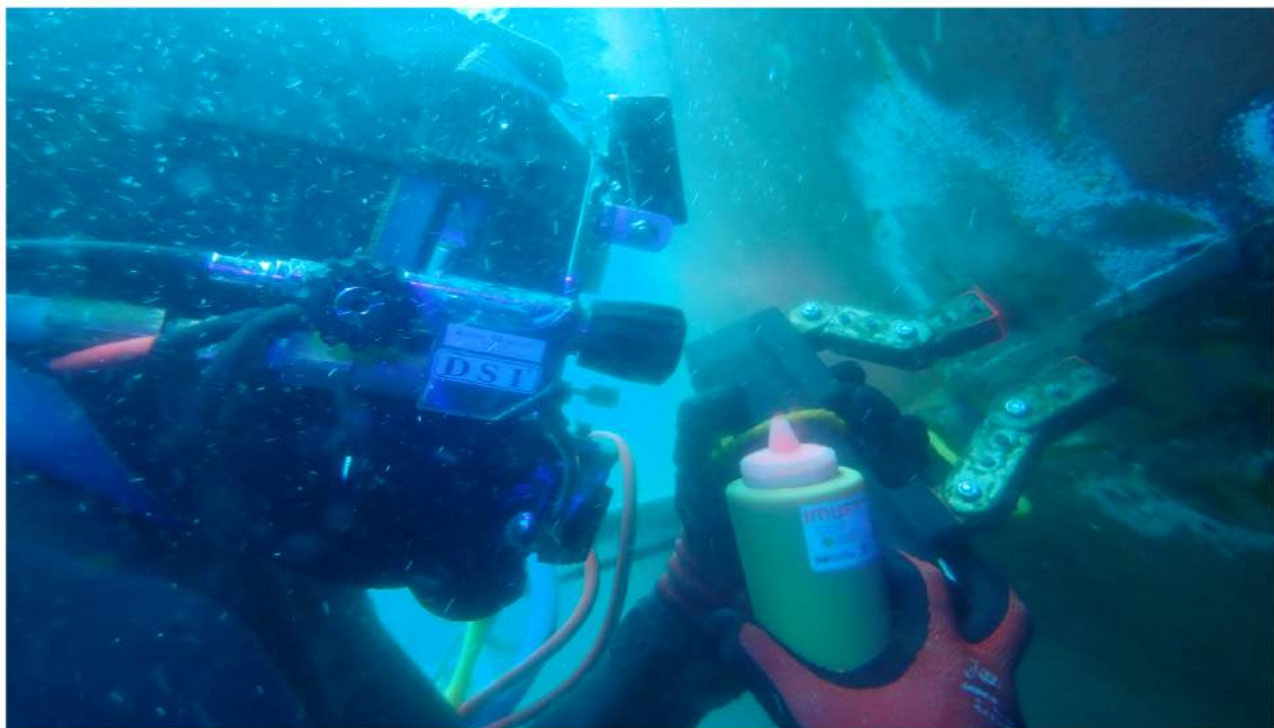
Talleres' divers have been trained and are certified to perform Underwater Magnetic Particle Inspections (UW-MPI). This method of testing is done to find fractures or hair line cracks on the structure and welding seams of a vessel that may not be so visible to the human eye.

Cracks are found due to stressed and fatigued points on a vessel or due to lack of fusion on a welding procedure. MPI will clear the scenario and will give our divers the correct length and location of the crack being inspected. Testing of weld butts underwater are done basically in two scenarios. The first one is when performing underwater welding repairs in which class needs proof of an adequate weld quality after completion.

The other scenario is when performing underwater hull maintenance jobs or inspections in which cracks are found on the hull or on the rudders. MPI is an added value that ensures the safety of the ship and helps ship owners know the actual condition of their assets.

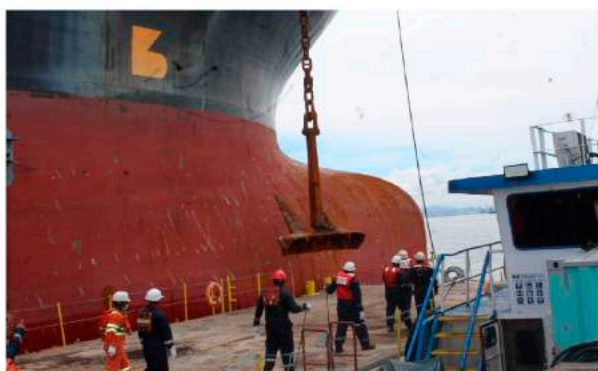
Earlier during the past month we were contracted by a ship manager in Asia to perform complete repairs on the starboard anchor chain of a Neo Panamax vessel at Balboa anchorage, under the guidance of Lloyds Register surveyor. Job consisted of the repairs of more than 3 dozen loose links, more than 70 weak studs, and the replacement of more than 10 missing studs. Furthermore, some of the stud's axial and lateral positions had exceeded their limits.

Job needed to be accomplished with special welding procedures specification (WPS), certified welders' PQR, and BV Grade 3, which Talleres could gladly provide. Upon arrival to Balboa anchorage, our certified team as well as our fully equipped supply boat and crane barge, were waiting for her to drop anchor.

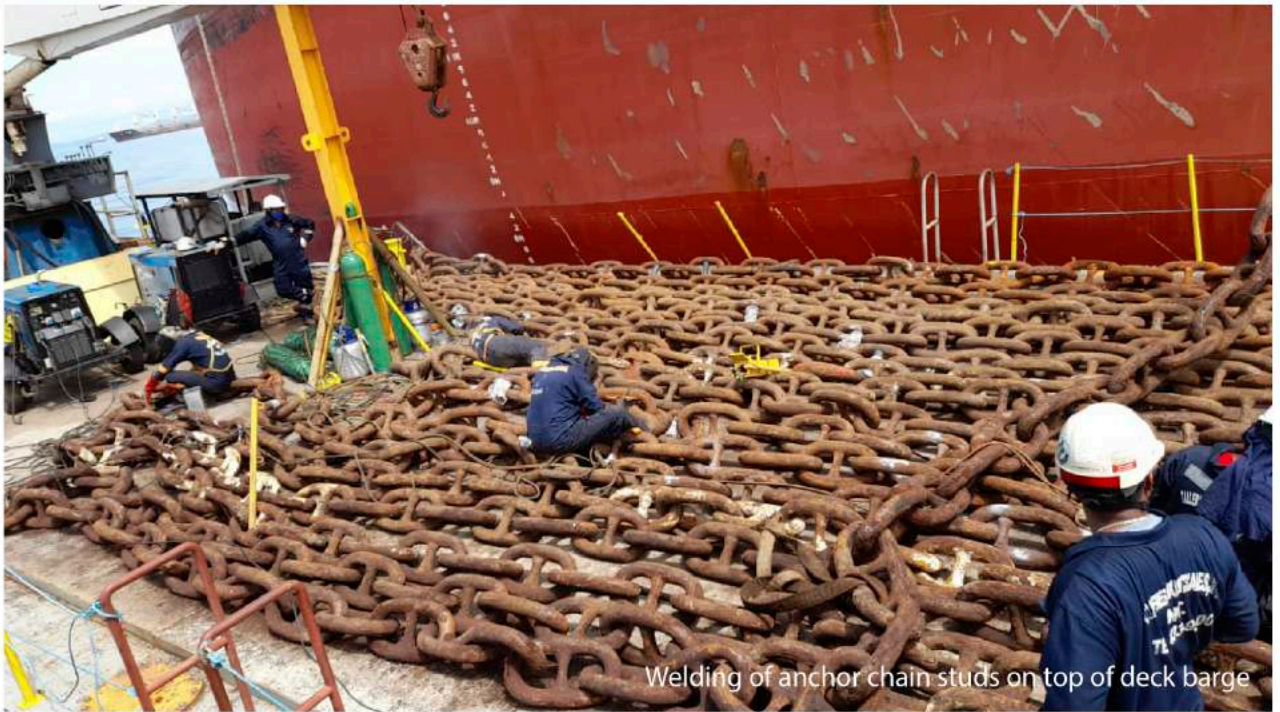
Welding of anchor chain studs on top of deck barge

Vessel crew deployed the anchor and chain onto the barge deck and our crew and barge crane operator positioned the chain in order to commence repairs. First, a general cleaning of the links by brushing and grinding had to be done in order to have the surface ready for welding. Welding team immediately started to identify working studs and evaluate damages with the assistance of the NDT team. Pre-heating and welding as per WPS were performed. After welding and cooling down of surface, MPI test was performed on all kenter shackles. There are essentially no jobs usually done at dry dock that Talleres cannot perform afloat.

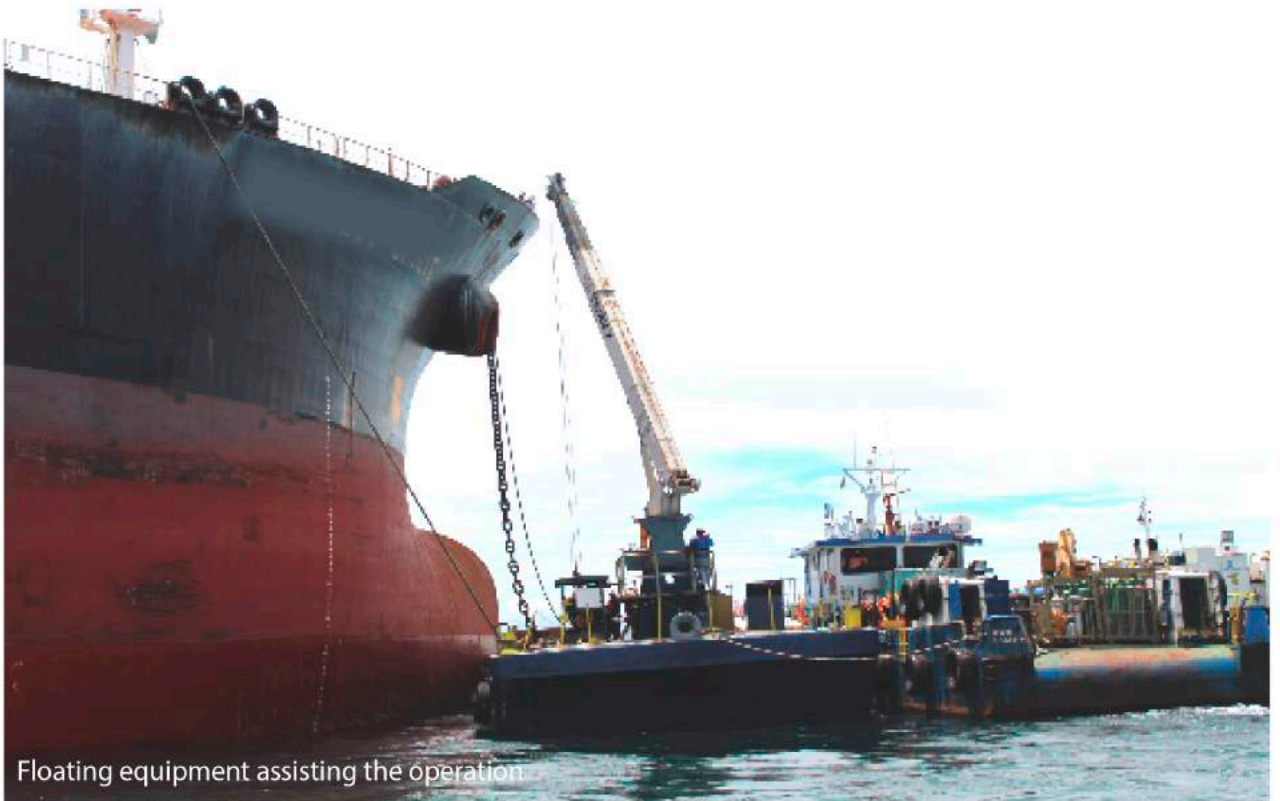
Floating equipment assisting the operation
