TALLERES INDUSTRIALES, S.A.

MAGAZINE Edition 11th

IN SITU STRUCTURAL REPAIRS ALONG THE ENTIRE LENGTH OF A JIB BOOM CRANE

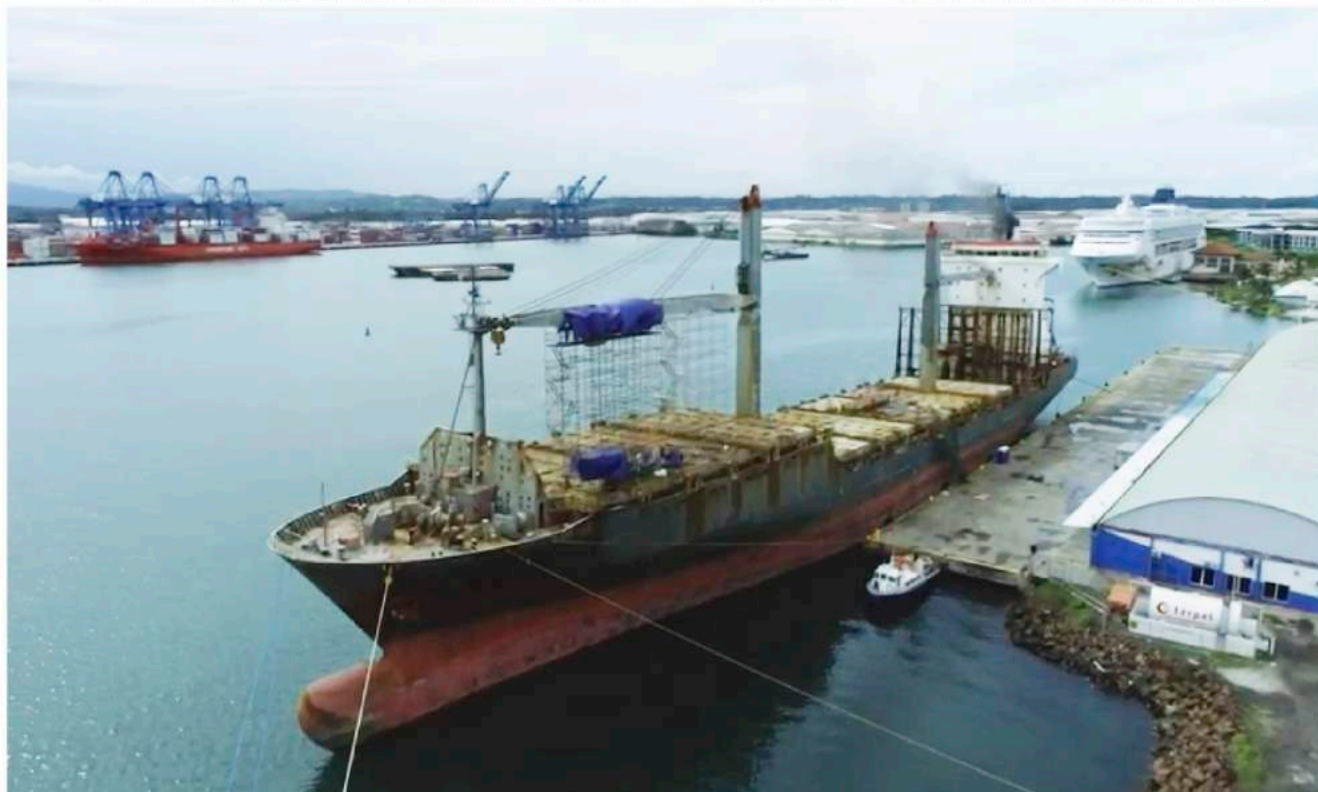
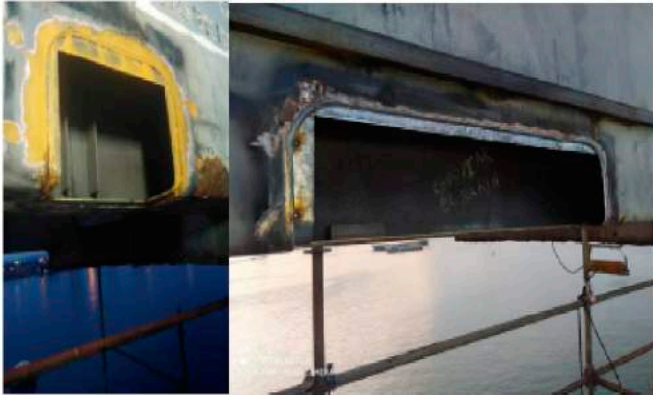
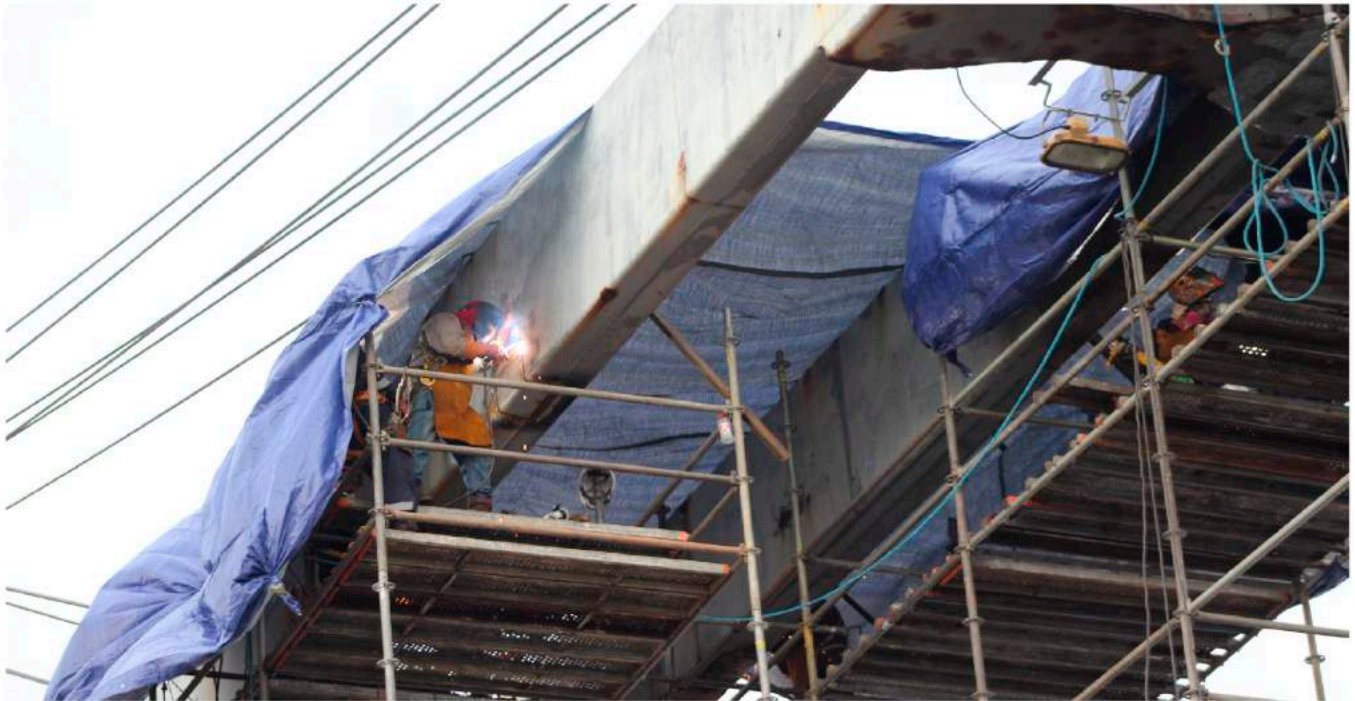
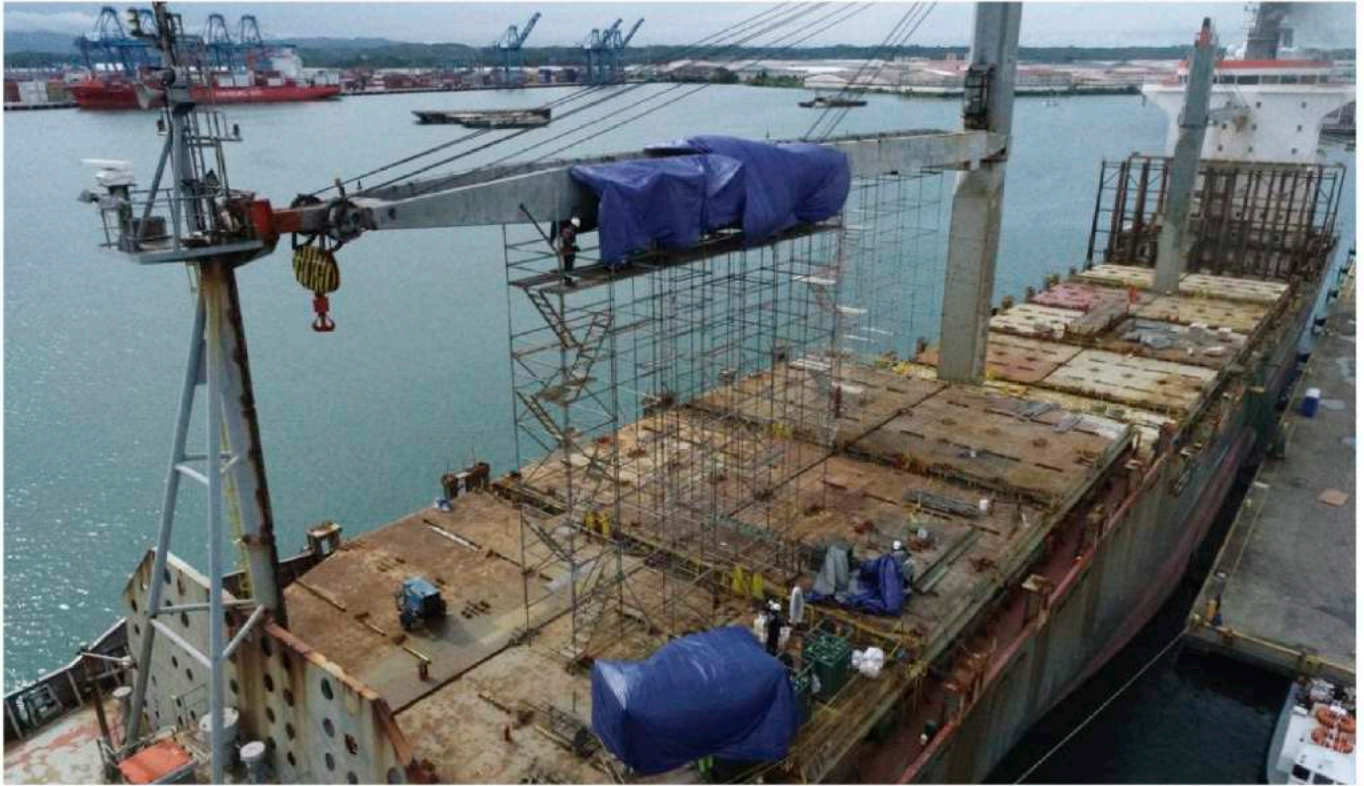
Earlier this month we performed a major structural repair to a jib boom crane in situ at Colon 2000 terminal on the Atlantic side of the Panama Canal. The 16,000 gross-tonnage container vessel needed to do some repairs on her forward crane before taking her next contract, on an urgent basis. The first step was to evaluate the extent of the damage and possible repairs of the vessel's booms plates that required renewals in a limited time. Several indicative photos and a sketch with the affected areas were given to our engineers to make a visual inspection upon arrival and validate the condition by taking ultrasonic thickness measurement along the jib. After inspection was completed, a proposal was given to the owners.

The requested proposal involved doing repairs in situ by erecting close to 1000 cubic meter of scaffolding on vessel deck in way of the entire forward crane.

Multiple steel inserts had to be done through the entire length of the crane. Corroded areas were cropped, and new sections of plate inserts were bent, fitted, and welded in situ by class approved welders and using approved welding procedures. After completion, all new welds were tested with MPI and Ultrasonic methods.

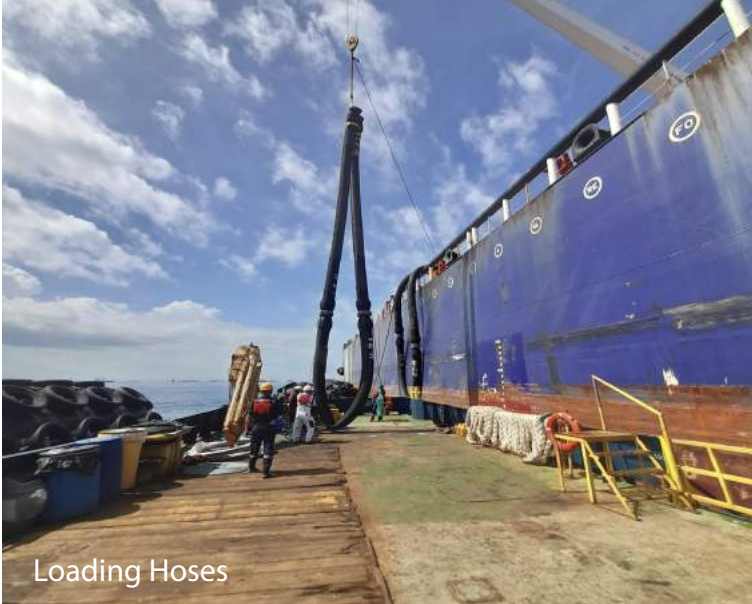
Loading Hoses

The location was assigned by the Marine Authority. Once alongside, STS personnel were transferred onboard with the crane using a certified man lifting basket. Four primary fenders and two secondary fenders (Yokohama Fenders) were installed in position on the service ship (SS). Two 12" diameter High Velocity cargo hoses were lifted up by vessel crane and connected on one end. Each hose had a max capacity of 40,000 BPH (barrels per hour) giving a maximum transfer rate of 80,000 BPH.

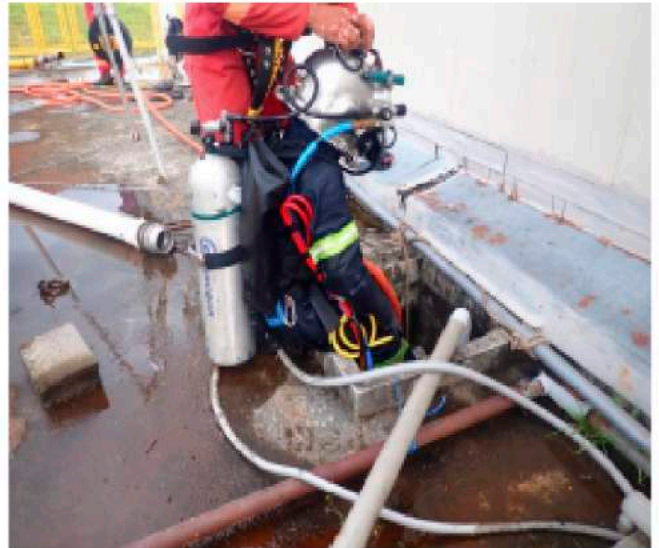
On this specific task performed earlier this month, we were hired to inspect a hydroelectric gate and afterwards to perform cleaning and dredging of sediments accumulated in the system. Underwater dredging was performed using the siphon method commonly used for removal of sediment in small reservoirs with the use of compressed air, pumps, and hoses.
