TALLERES INDUSTRIALES, S.A.

MAGAZINE 7th Edition

MAJOR STRUCTURAL REPAIRS ON THE STEM OF A VESSEL

RECORD-BREAKING PERMANENT UNDERWATER REPAIR – 8 METERS IN LENGTH

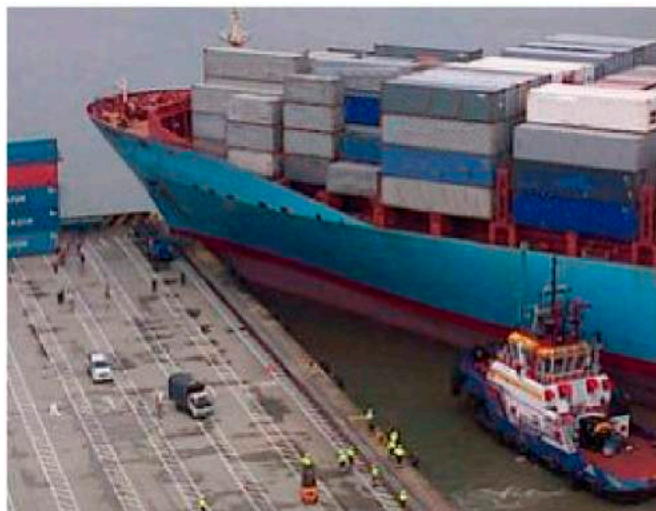
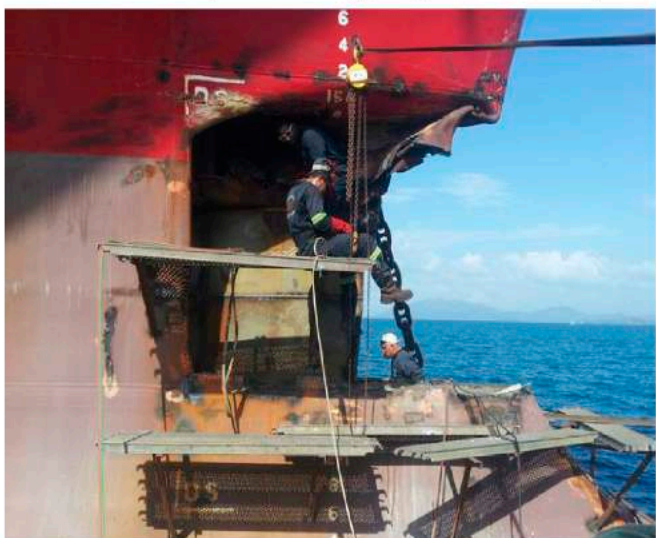
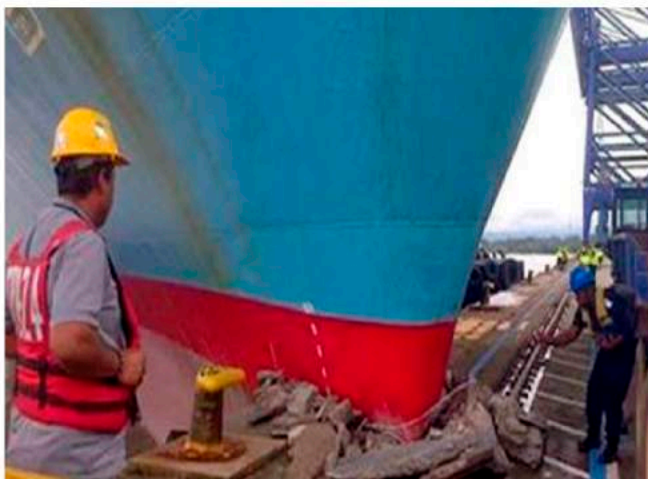
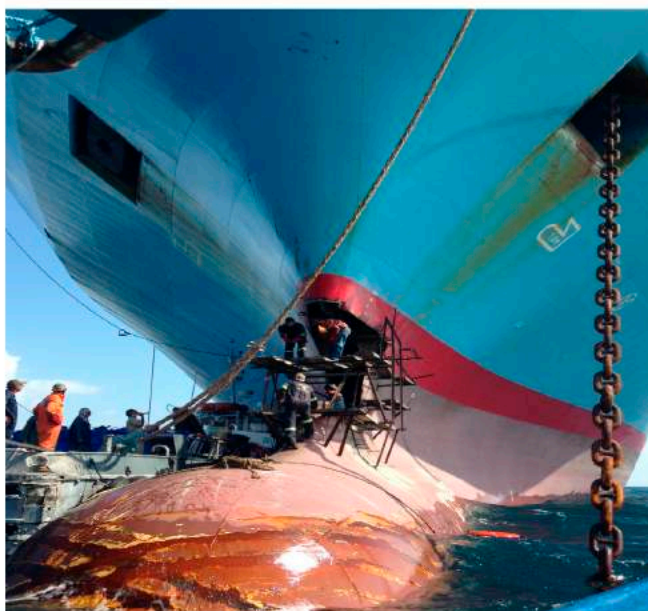
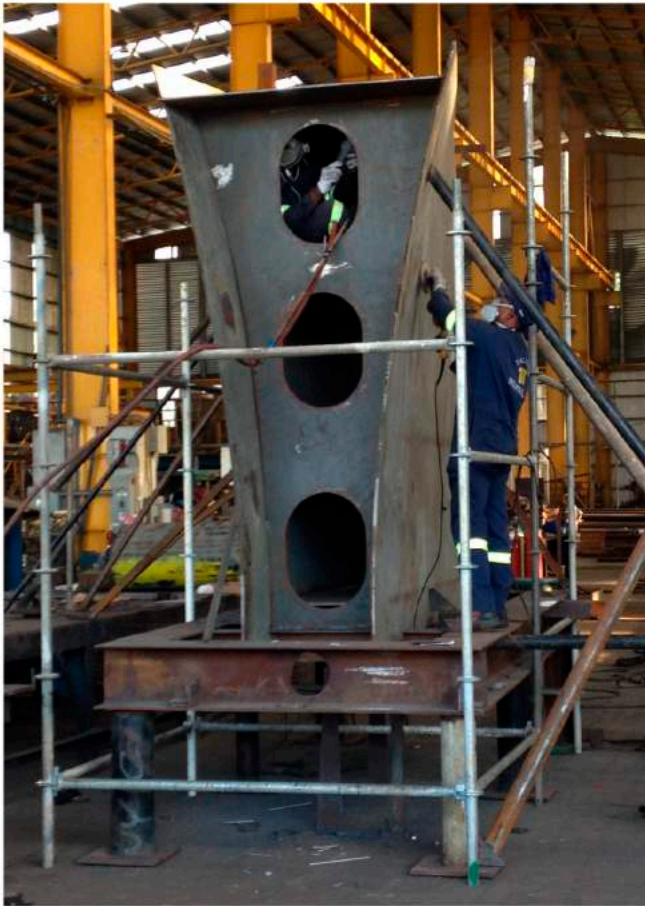
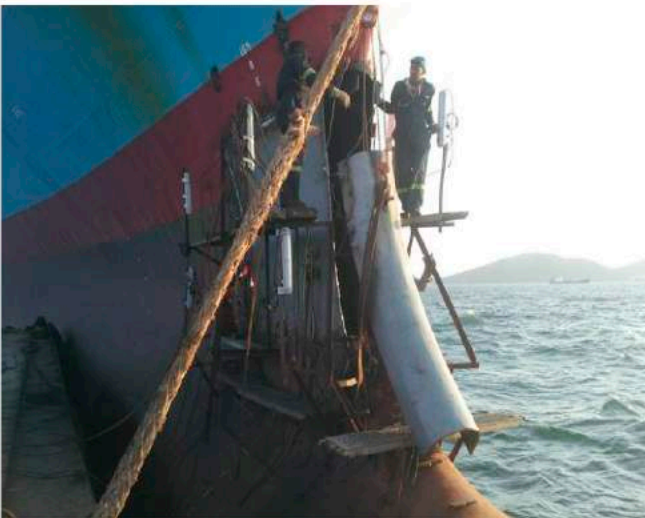
Here are the facts on this outside-the-box mission: 75,000 gross ton container vessel of an overall length of 300 meters and 40 meters in breadth, collided the wharf at the terminal of Buenaventura, Colombia, during berthing maneuvers.

We were contacted almost immediately to mobilize to Colombia to inspect the damage and come up with a solution to perform temporary repairs to let the vessel complete its voyage, and then come to Panama for permanent repairs.

The day after the incident and during cargo operations, our production manager and steel foreman inspected the damage and arranged temporary repairs with a local contractor.

The agreed repairs basically condemned all manholes by welding steel plates on them and making the vessel's forward section watertight to allow it to complete its cargo discharge in South America and then to come up to Panama for permanent repairs. At the same time all necessary measurements were taken to start procuring all necessary resources for the prefabrication of a 6-ton high tensile compound shape block.

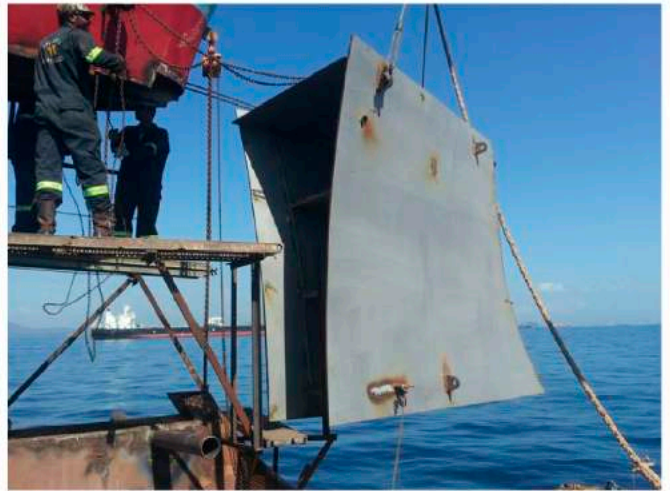
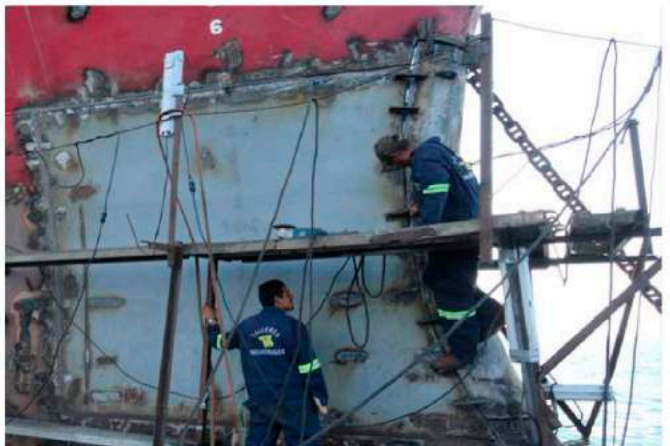
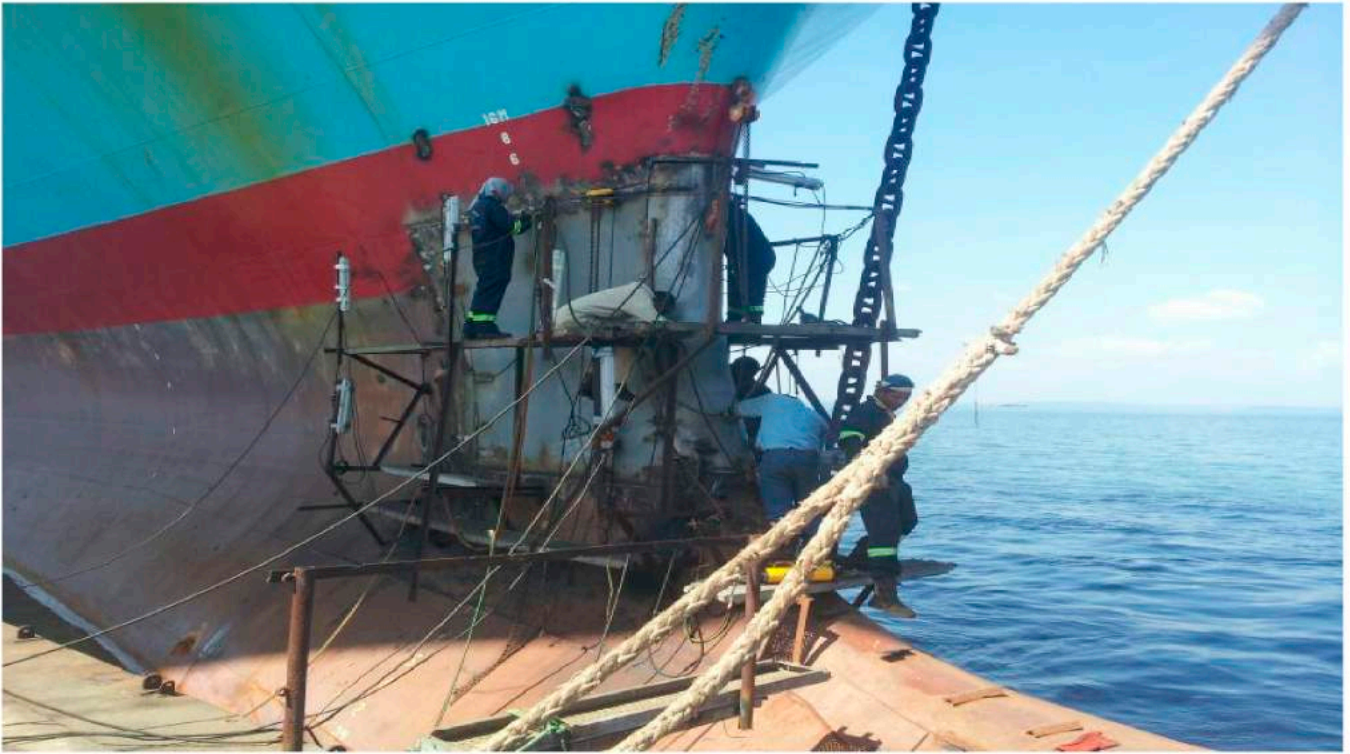
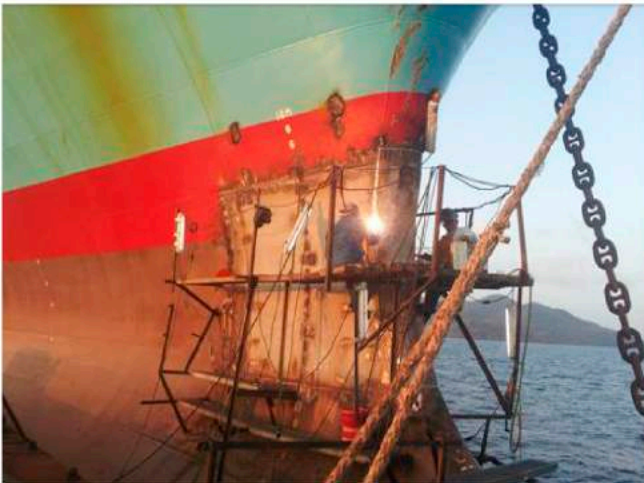
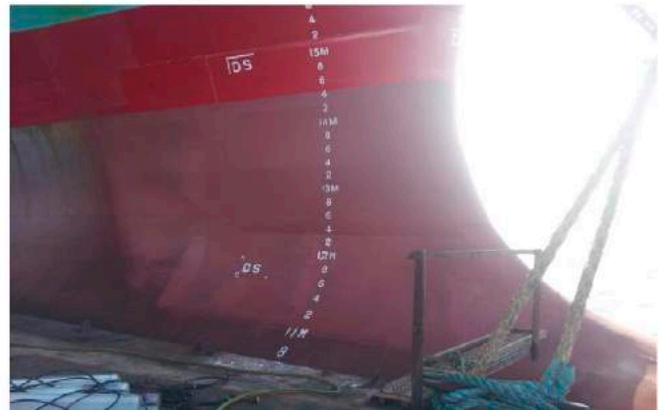
Upon its arrival to the Balboa anchorage in Panama, our floating deck barge, which included a crane and all the equipment and gears, was tied alongside its bow. Immediately, staging was built around the damaged sections, which were then cut. At the same time final measurements were taken to perform any final adjustments on the block being built at our main workshop.

Industrial rollers, heating machines, a press, and hydraulic jacks were used to achieve the perfect shape of the block. Once the 3,400 mm x 3,050 mm EH36 compound shape block was completed, it was transported to Balboa to be installed by our best fitters, who had to play surgeon for the delicate fitting and adjustment process. The outcome was perfect, making the external and internal production welding process easy

All welds were ultrasonically tested to satisfaction of the class surveyor and attending superintendent. For this magnificent repair, the final touch-up was very important – mechanical cleaning, grinding, and painting of all surfaces under the original specs. The repairs were completed to the full satisfaction of class surveyors, owners, and insurance representatives. We at Talleres, are eager and always ready for difficult and challenging jobs. No matter the season, no matter the complexity, no matter the location.

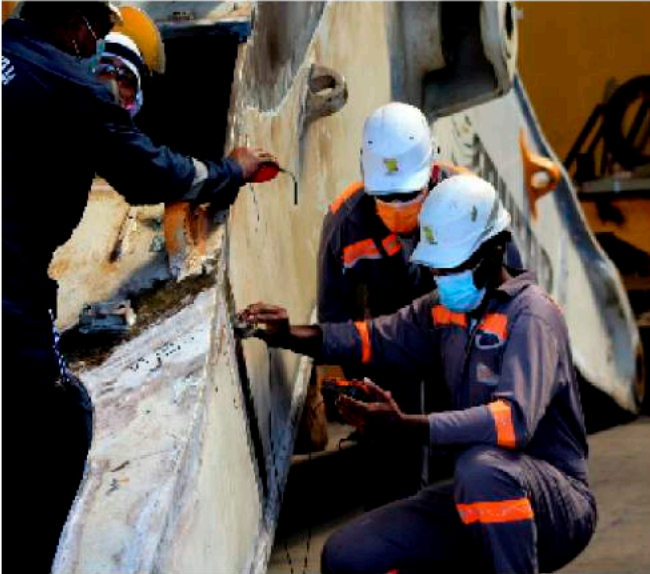
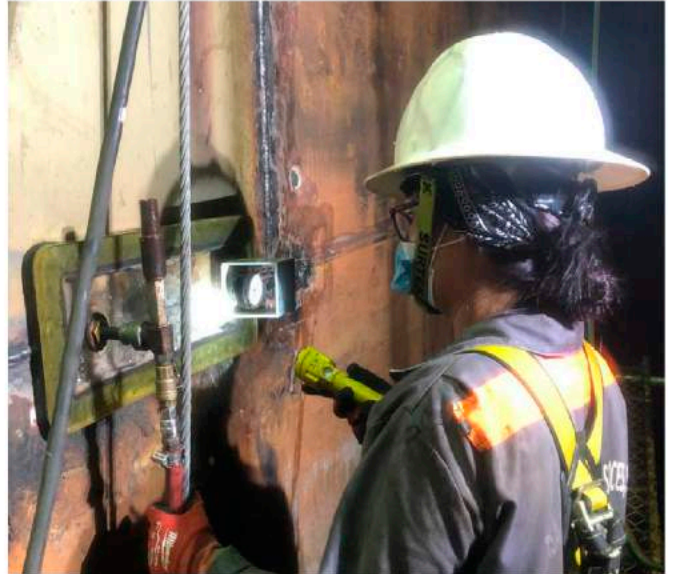
Within our group of companies, one of our youngest ones just opened a new division - the ultrasonic thickness measurements. On this new diversification, we have two experienced engineers in their mid-30s and the rest are young, enthusiastic, and full of energy engineers in their mid-20s. Even though they are young, they have a lot of mileage covered performing tests for the parent company Talleres Industriales' quality control processes every day for projects and floating equipment maintenance.

Our UTM project performing engineers are also qualified and certified NDT Levels I, II, and perform all types of visual, liquid penetrant, ultrasonic, magnetic particles, and vacuum box testing onboard vessels and in our workshop. We feel proud of this promising division that has a great future and career path for our team.

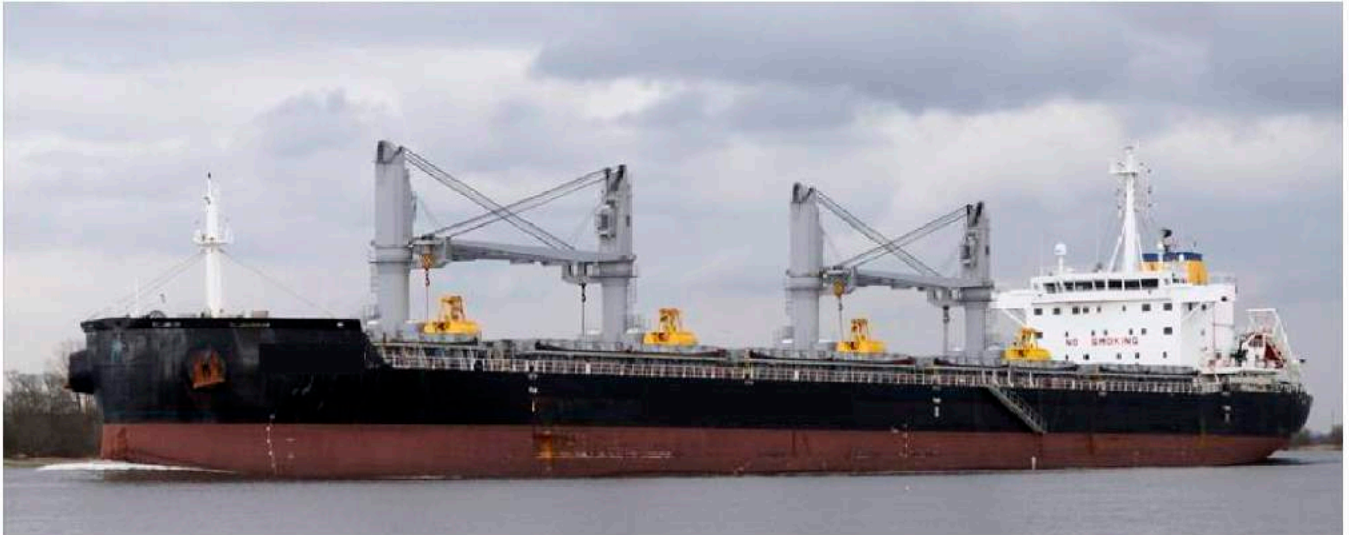
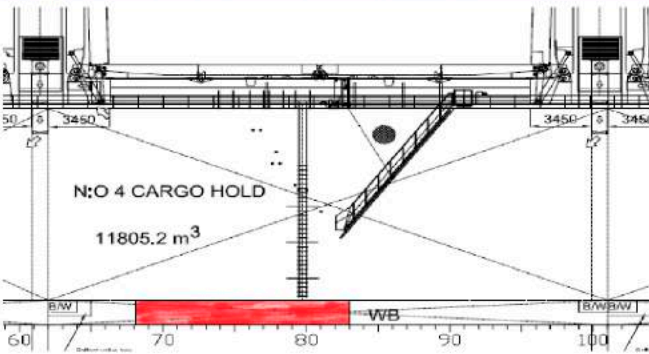
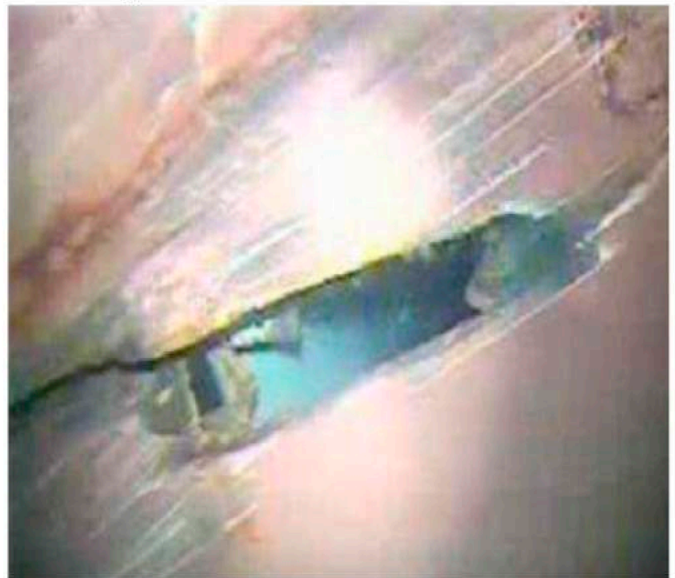
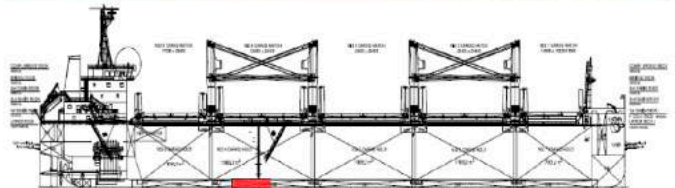
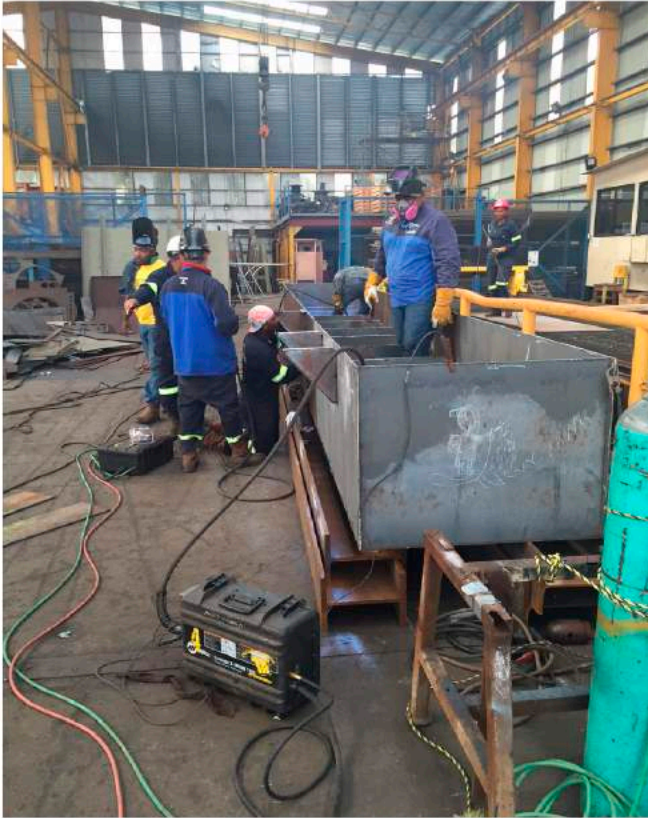
A 25,303 gross ton Bulk Carrier ran aground at Buenaventura, Colombia, suffering major structural damage underwater on its external plating and internal girders.

Another record-breaking challenge came to our door, to perform a permanent underwater steel renewal on an 8-meter rupture on the No. 4 port side double bottom ballast tank of a brand-new vessel.

The grounding opened a rupture in the bottom plates of about 7,300 mm long and 200 mm wide transversally, located between frames 70 and 80. This grounding also caused damage to all the internal structures between the frames and the longitudinal structure. The complexity of the repair required immediate inspection by one of our team's experts, who immediately mobilized from Panama to witness the underwater survey.
