TALLERES INDUSTRIALES S.A.

MAGAZINE

DRY DOCK AT SEA

FIRE IN AN ENGINE ROOM OF A CONTAINER VESSEL

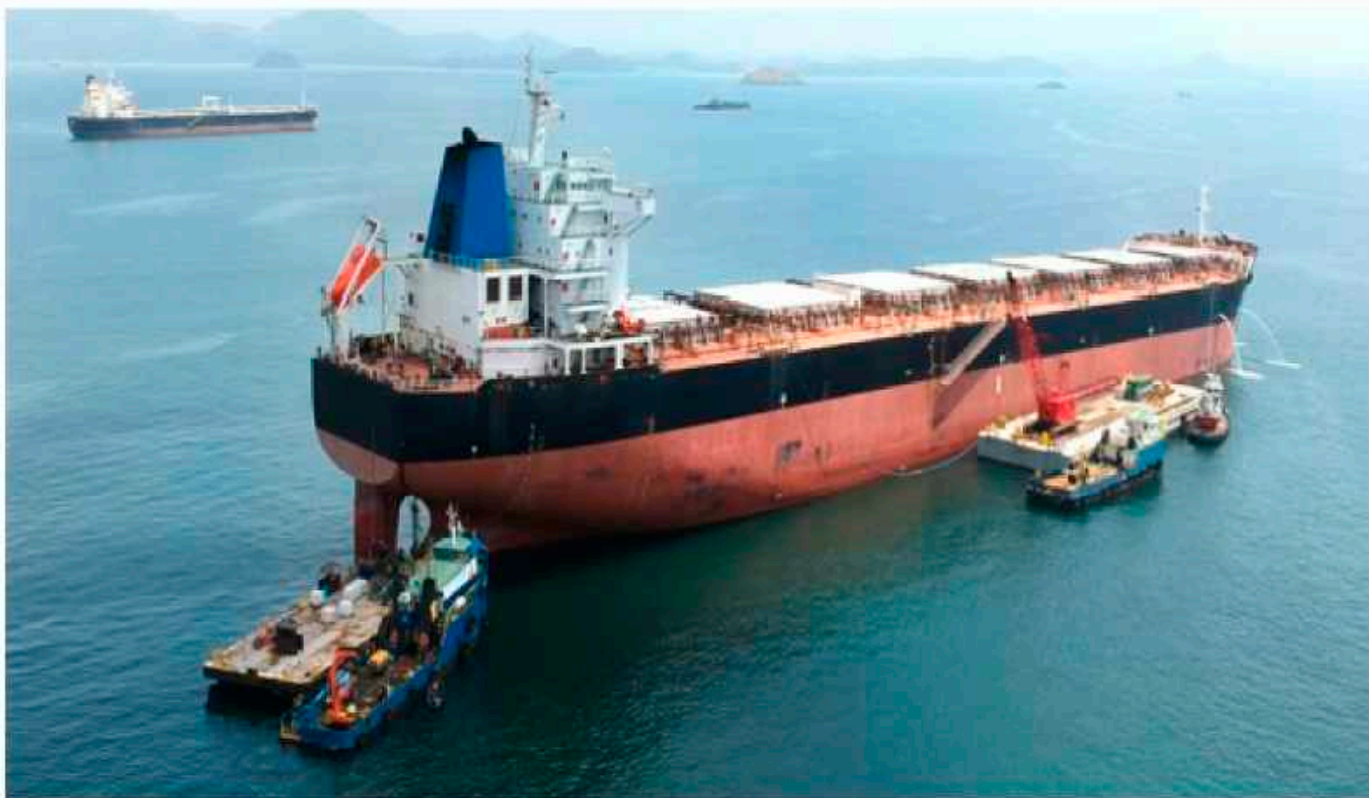
In the middle of the Pacific Ocean, on her passage from Korea to Mobil, USA, via the Panama Canal, a Panamax bulk carrier broke its intermediate propulsion shaft. While arranging a salvage tug, the owners had two options. Either they took the vessel to a dry dock in the West Coast of the USA or they could come to Panama to perform afloat repairs at the Balboa Anchorage, since a dry dock or lay berth for this size of vessel was not available.

The original job scope was to replace the intermediate shaft and check the whole propulsion system to see if any additional repairs were required. The original plan involved trimming the vessel, removing the propeller, pulling back the tail shaft, cutting an access at one side of the hull, removing the broken intermediate shaft and installing the new one.

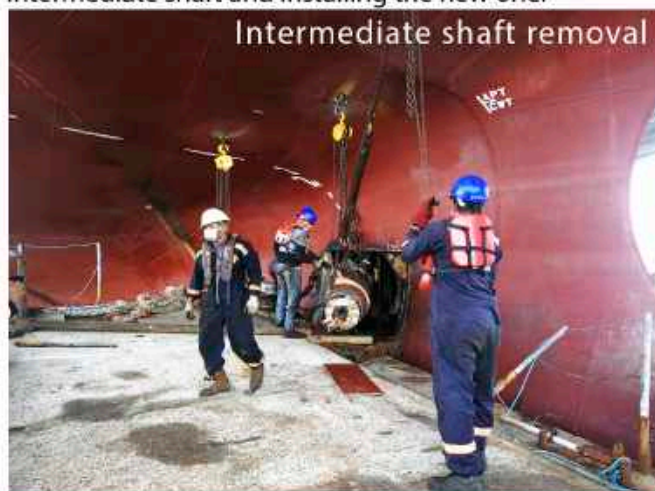
Intermediate shaft removal

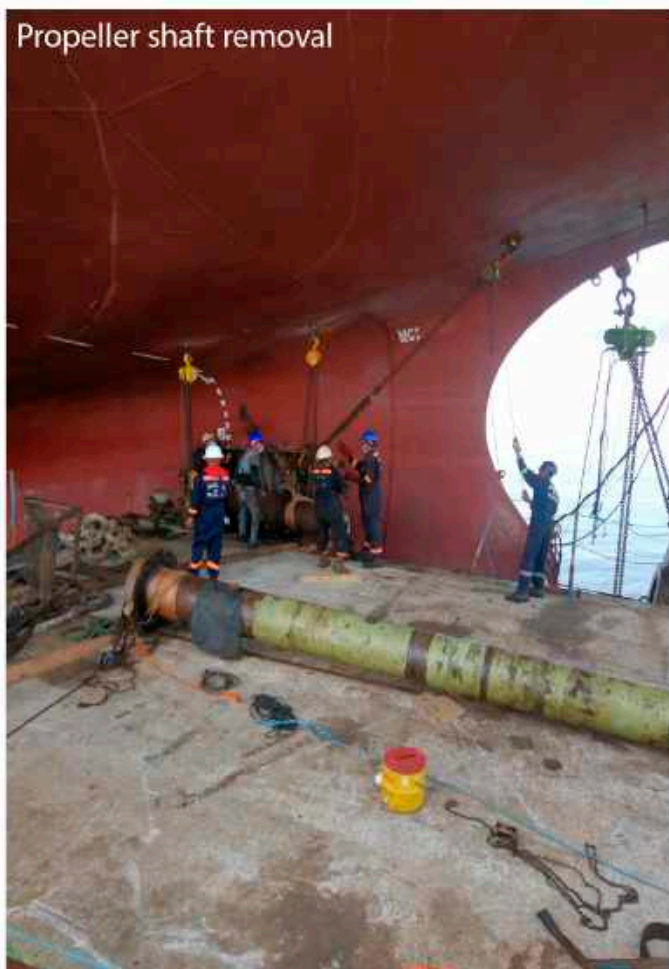
Propeller shaft removal

Once the vessel was trimmed and the inspection was done, we noticed that the tail shaft, the stern tube bearing and the forward- and aft seals were also damaged. The ship manager ordered a new bearing, a spare tail shaft, and seals.

Therefore the new scope of the work onboard involved trimming the vessel with submersible pumps to allow the desired draft, removing the propeller, and cutting an access through the hull to remove the broken intermediate shaft, the intermediate bearing, the main tail shaft and the damaged stern tube bearing.

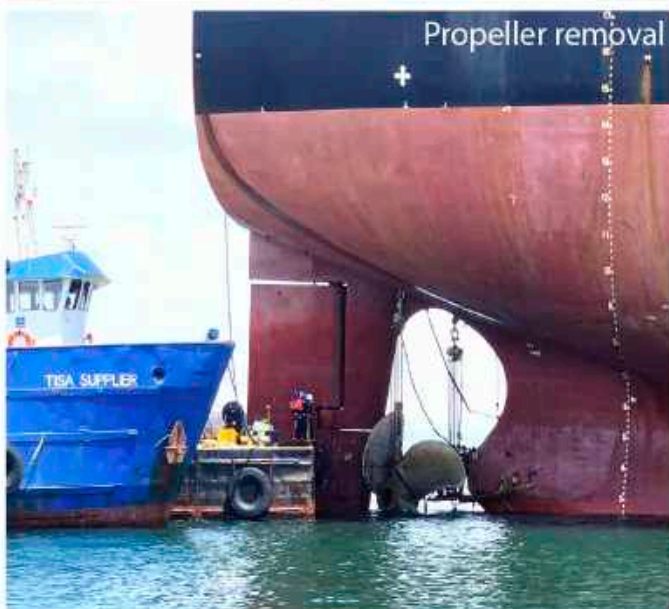
Propeller removal

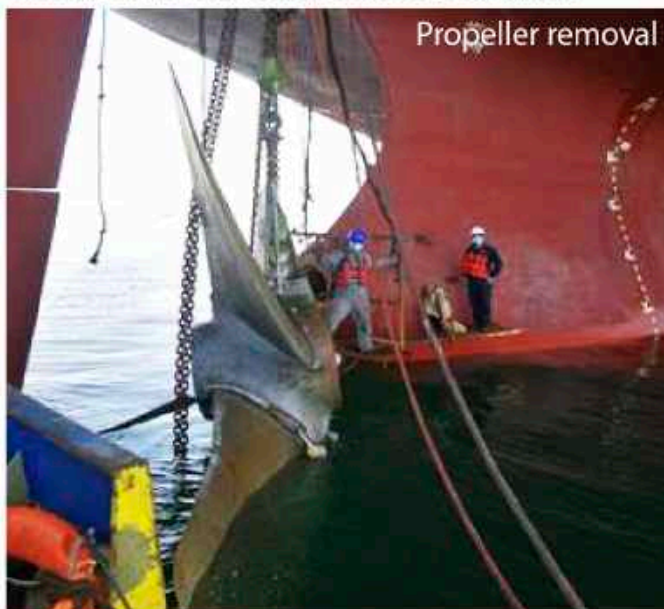
Propeller removal

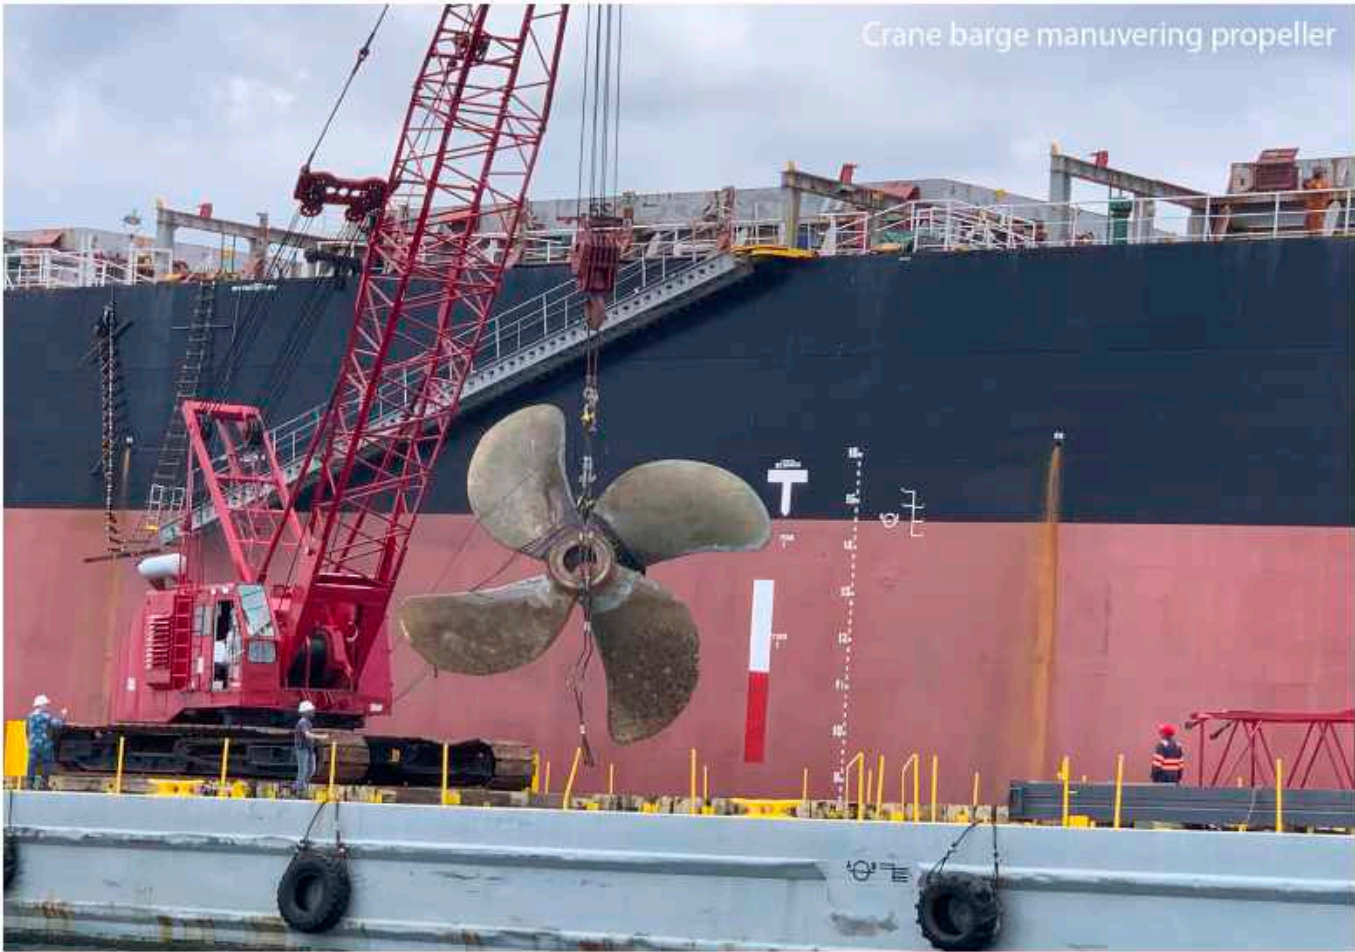
Crane barge maneuvering propeller

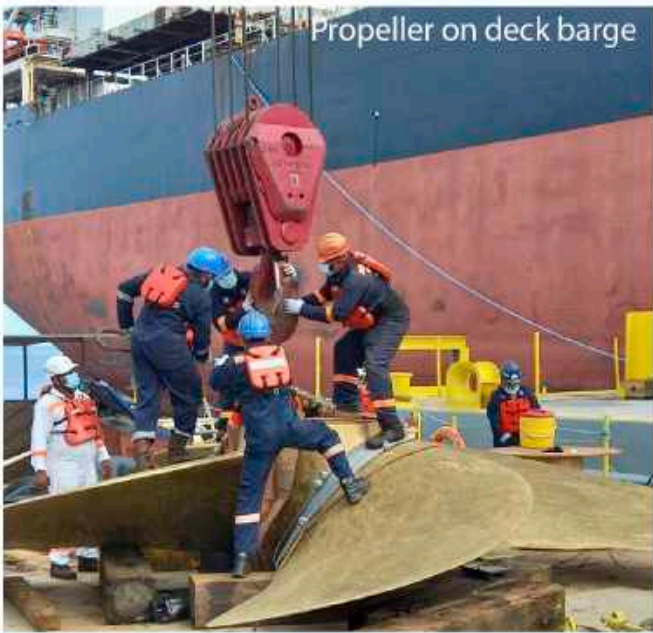
Propeller on deck barge

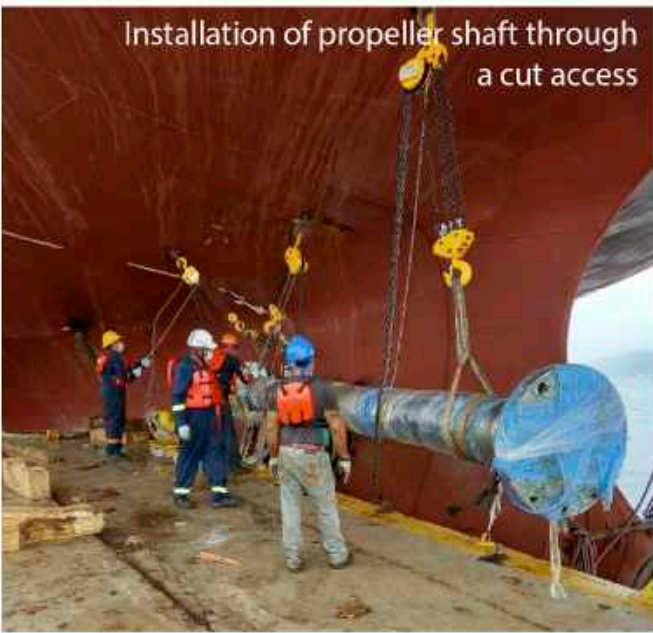
Installation of propeller shaft through a cut access

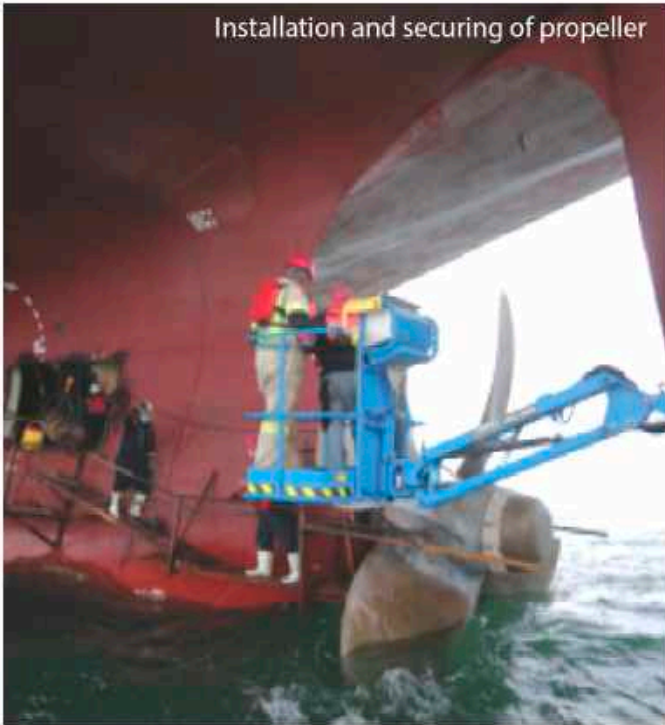
Installation and securing of propeller

Finally, TISA installed the propeller afloat and performed a sea trial with satisfactory results for the class surveyor.

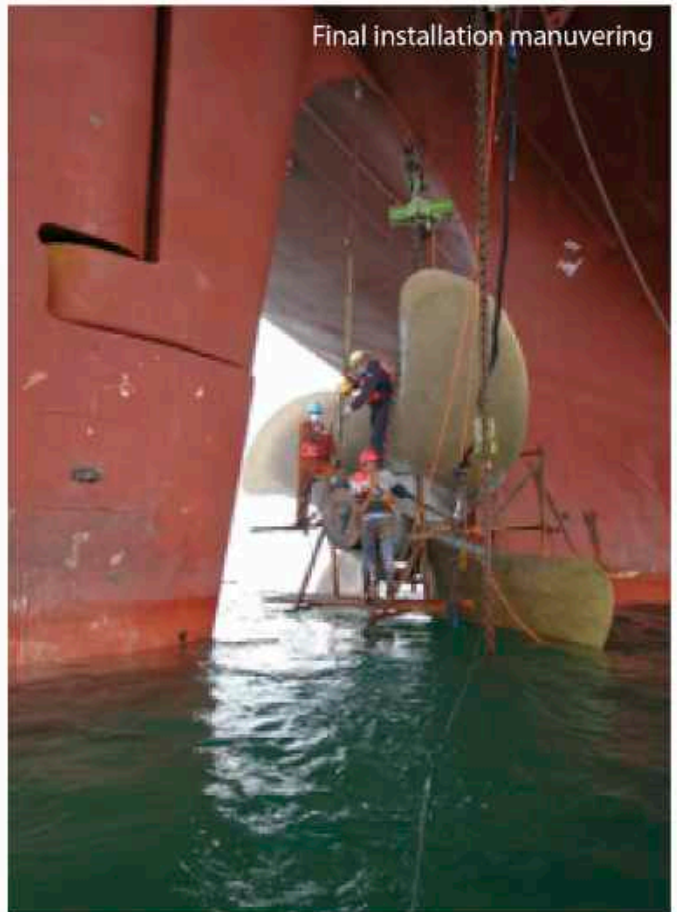
Final installation manuvering

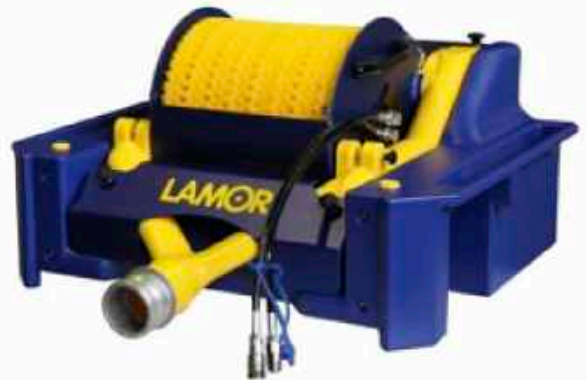
NEW INVESTMENT - BRUSH SKIMMER MINIMAX 25 - 366078

The Minimax 25 skimmer is a light-weight new generation modular oil skimming unit that is easily transported and assembled. The Minimax 25 is designed to recover oil from the sea and nearshore.

The Minimax 25 consists of only three easily assembled parts, a skimmer body, a collection hopper and a brush module. Therefore, it can be disassembled in less than a minute facilitating cleaning and service. Disc and drum modules are available as additional optional equipment.

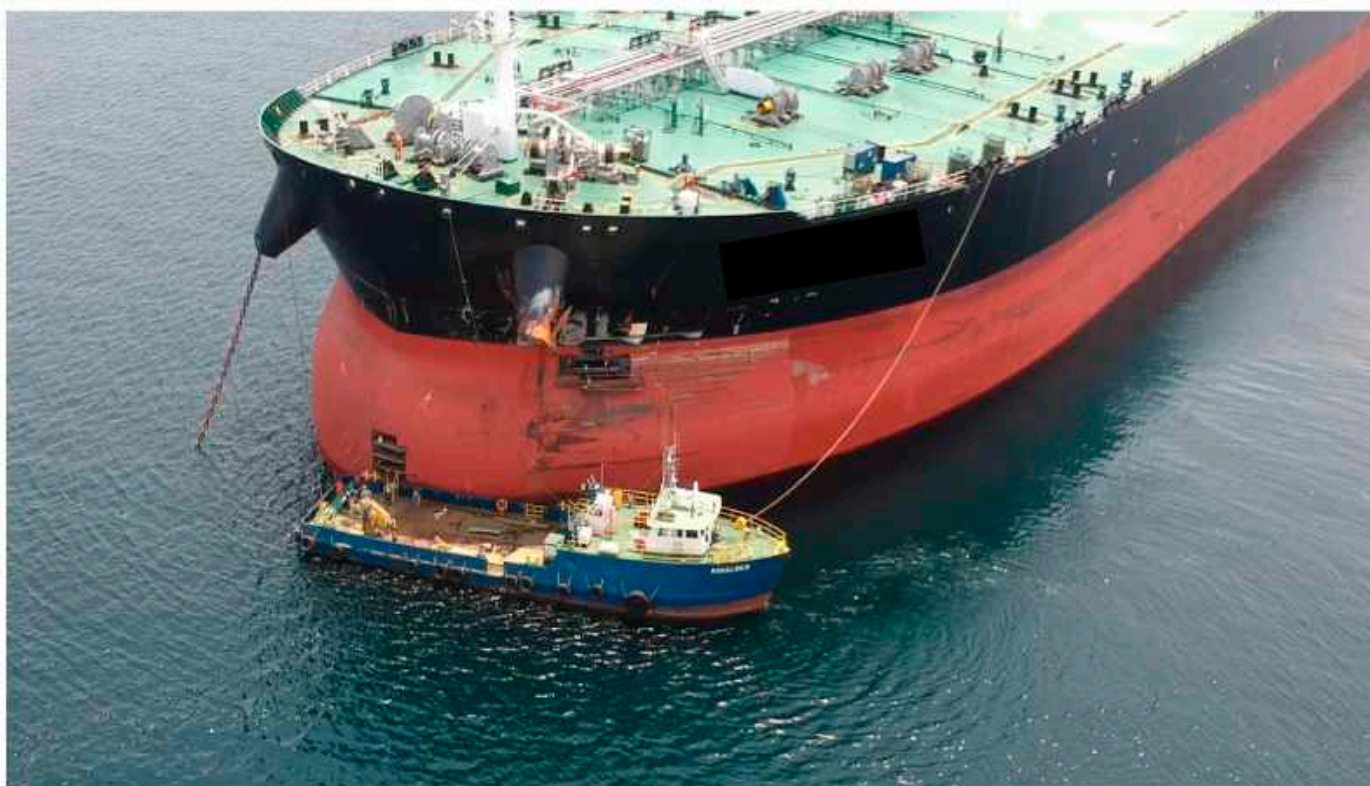
MAJOR AFLOAT STRUCTURAL REPAIRS

This time we undertook a major repair at the Balboa Anchorage on a Very Large Crude Carrier (VLCC), which hit a terminal pier +600km away from the Panama Canal Entrance. Initially we mobilized our team to temporarily assist the vessel to avoid further damage and prepare her for the voyage to the Balboa Anchorage.

Our engineers and certified technicians undertook the challenge to repair a section of the bulbous area and the side shape plate simultaneously. Both plates were rolled in our Workshop Roller Press, which can work with plates up to 31 mm high tensile. Upon completion of the repair job, it was verified by qualified personnel in presence of a Class Surveyor, who approved the service as a Permanent Repair.

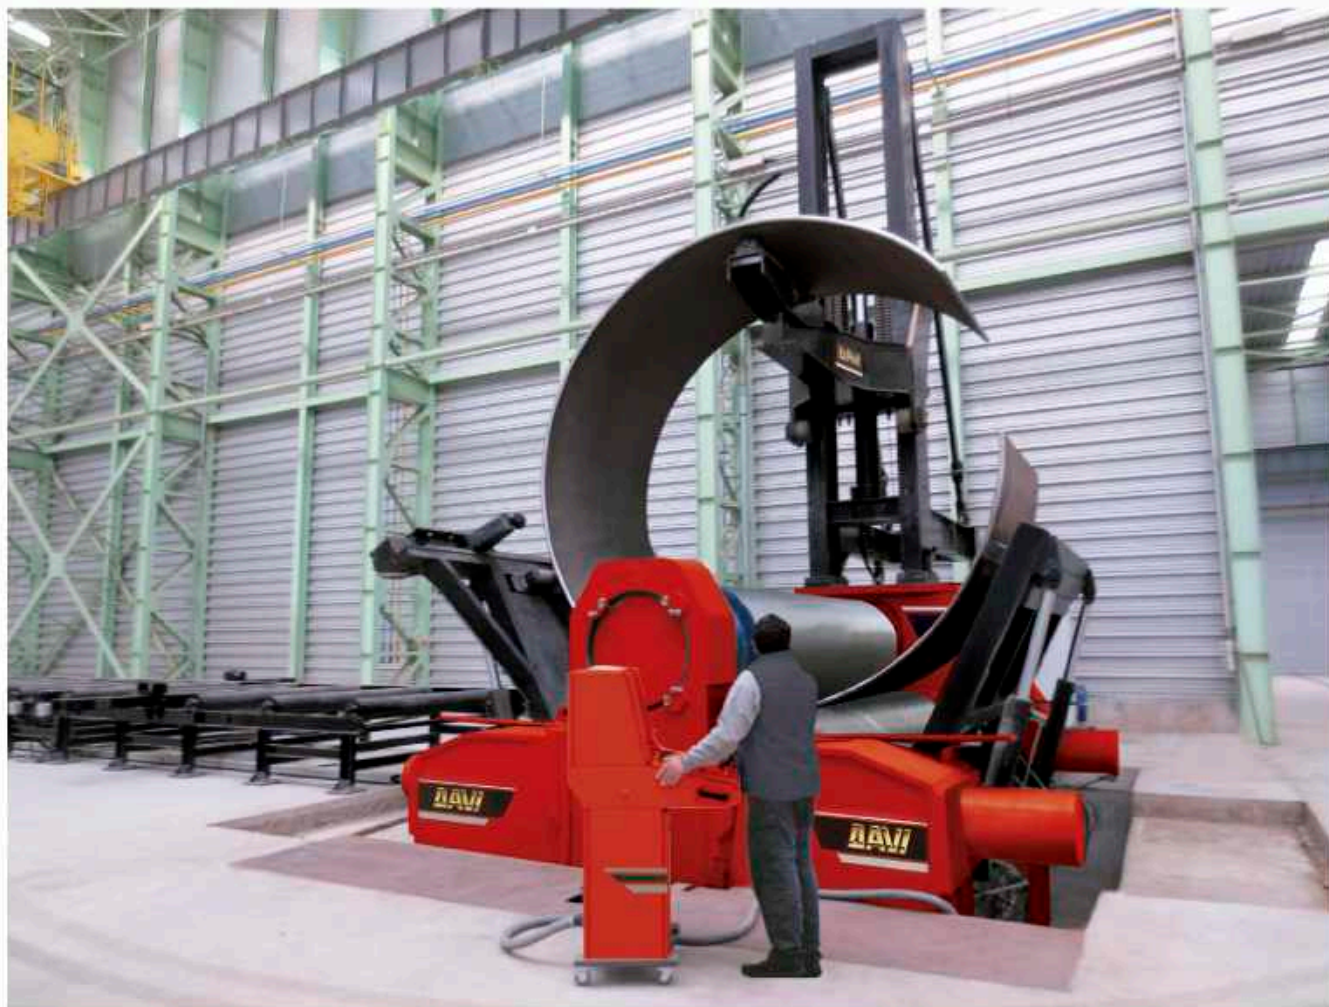
TALLERES PURCHASED THE MOST ADVANCED PLATE ROLLER MACHINE FOR THICKNESS GREATER THAN 80 MM

Talleres has invested in the most advanced plate rolling machine for thickness greater than 60-80 mm (2 – 3 inches). An individual machine, with many exclusive benefits, and the best solution available for “super heavy applications”. This 3 roller heavy duty machine will help us give shape to bulbous bows, stern areas of vessels, as well as cylinders and structures from the mining and energy industry. We will keep investing to fulfill our stakeholders’ needs.
