OCTOBER / 2021

TALLERES INDUSTRIALES, S.A.

24/7 SHIP REPAIRS AND MARINE SOLUTIONS

MAGAZINE 13th Edition

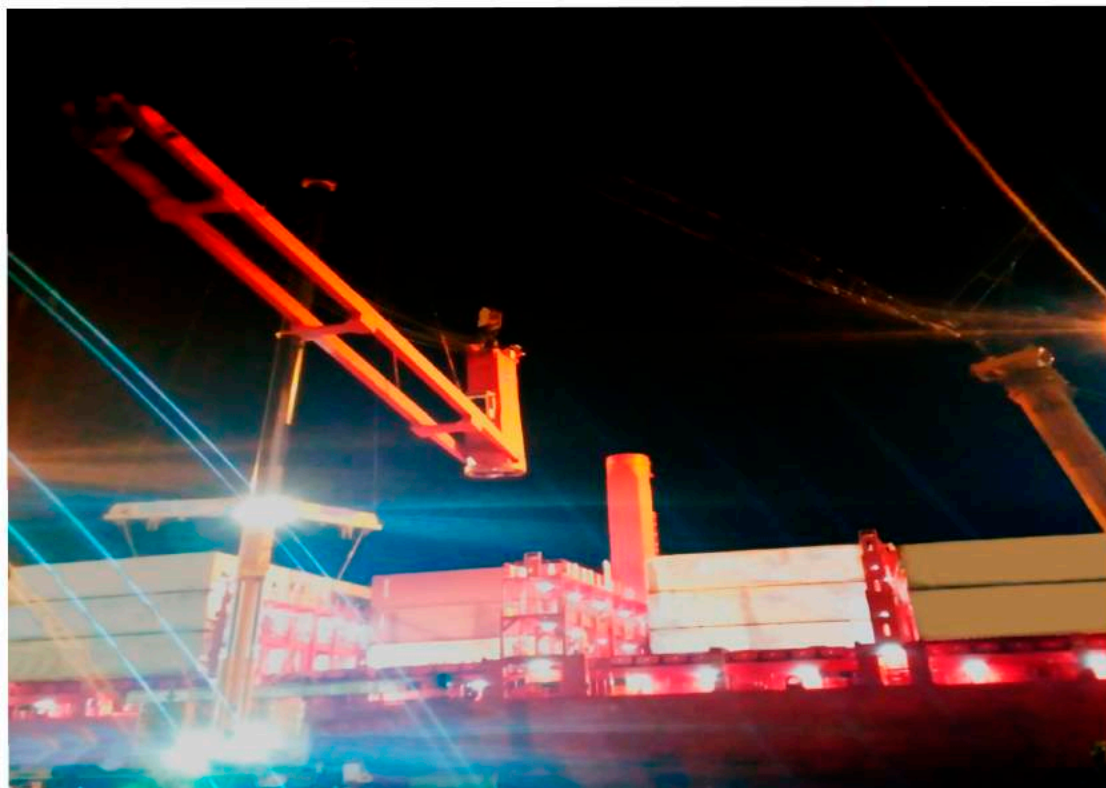
A 50,000 DWT Container vessel suffered a major damage on its deck crane when a shore gantry crane heavily struck its upper structure during cargo operations.

After initial inspections, structural damages were found on its top tower sheaves, sheaves support and railings. The vessel needed to perform an immediate temporary repair to continue its voyage and Talleres was called to assist. Talleres' engineers boarded the vessel to secure the crane structure and wires, to complete its voyage and unloading of cargo. Simultaneously we prepared a repair plan for its permanent repair on its return trip.

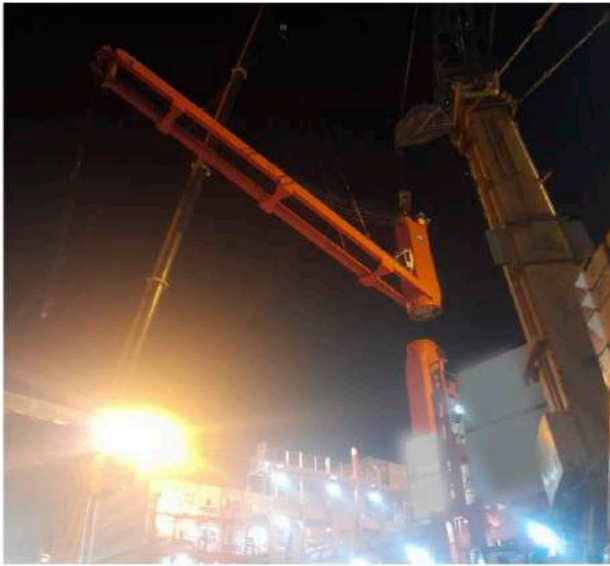
Once the vessel was back in Panama, we started the trickiest part of this operation which was the removal of the complete crane at lay berth, using two heavy lift shore cranes.

This phase of the job lasted 36 hours in which our personnel worked 24/7 with the highest standards of safety. The crane was secured with shore cranes, which worked together and in coordination to distribute the load. Our engineers, fitters and mechanics secured all the wires and released the bolts and nuts from the crane pedestal to dismantle the crane. The operation was successfully performed, and the crane was secured on lay berth ready for the next phase. This story will be continued...

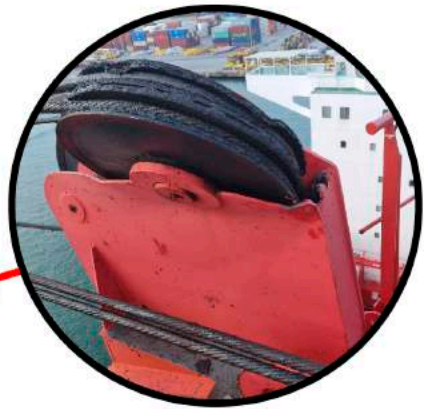
Damages on top tower sheaves, sheaves support

Once Talleres managed to secure the non-operational crane under the guidance of class and insurance, the vessel was allowed to complete its route. Immediately after vessel departure, Talleres got in contact with the makers to validate the repair plan and order the necessary spare parts for permanent repairs.

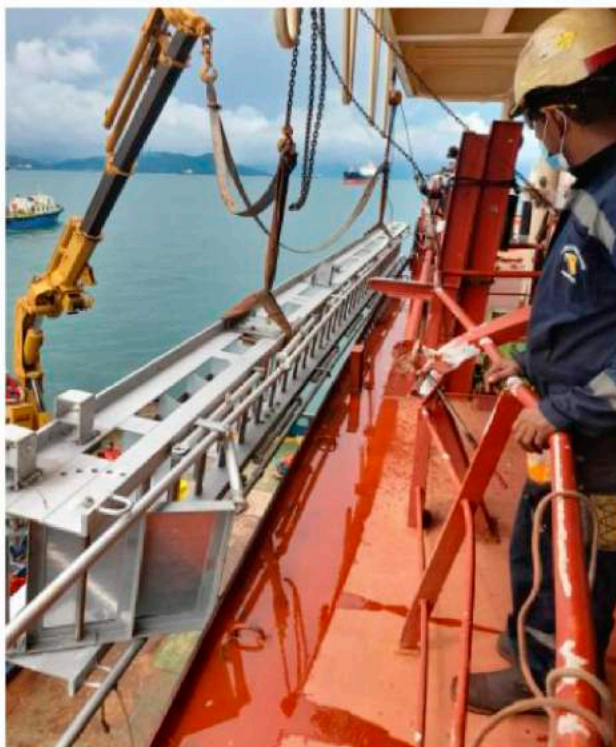
Talleres has been performing jobs from minor fractures to major structural damages on vessels' gangways. These repairs are performed in-situ onboard and at our workshop when major structural repairs are needed.

Talleres, can provide from class approved welders and procedures, to all logistical resources, including a critical one, crane barges to load and remove them from their positions on the ship.

We also have in stock aluminum materials, spares gangways, and as part of the process we perform quality control checks such as NDT and UTM to the damaged areas or new repair welds. Finally, we are equipped to perform load tests of the repaired gangways in our workshops and onboard after final installation and commissioning

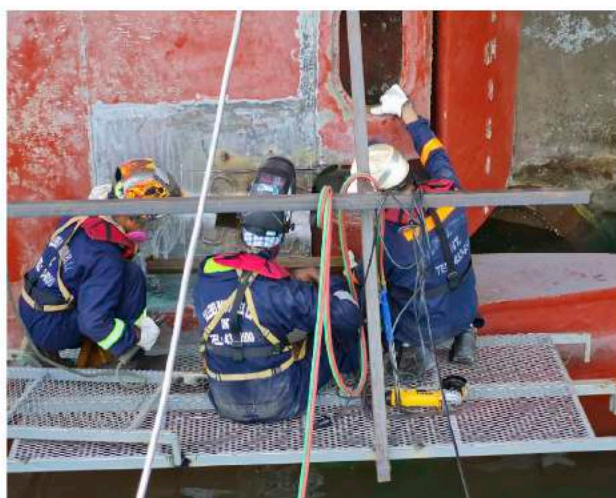
On this new challenge, our diving team discovered on a 40,000 DWT Bulk carrier some fatigue cracks on both sides of the rudder's shell plate and connecting castings area.

This vessel needed to perform repairs in urgent basis to continue its trading and discharge of its cargo. Temporary underwater repairs were done by wet welding the fractures and installing external reinforcement brackets to unload its cargo. On its way back to Panama on ballast condition, the ship's managers and our engineering department produced a repair plan to let them trade until its next dry dock.

Talleres' repair plan was approved by class. All the logistics and the equipment was arranged to be ready as soon as the vessel arrived back to Cristobal. The vessel arrived at the repair berth and started trimming on arrival to allow engineers to get down to the rudder to start the job with the use hanging scaffolding and the support of a deck barge.

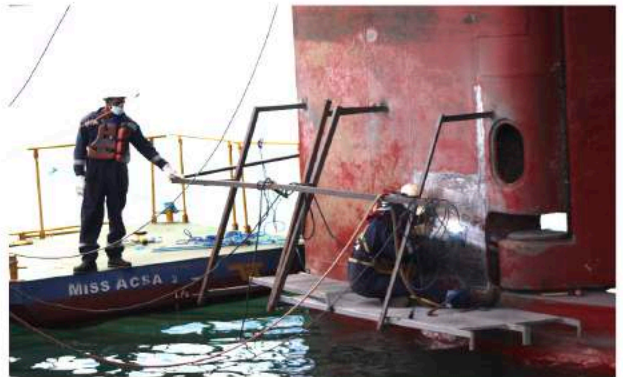
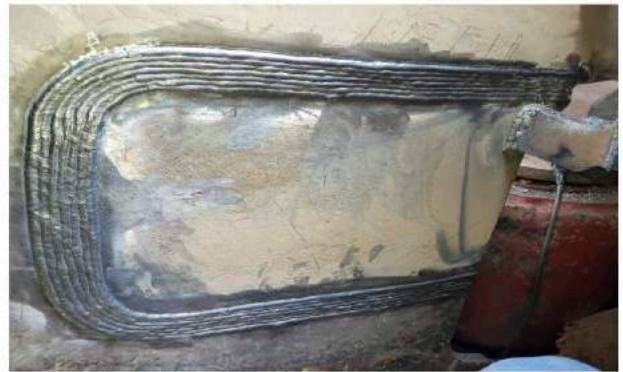
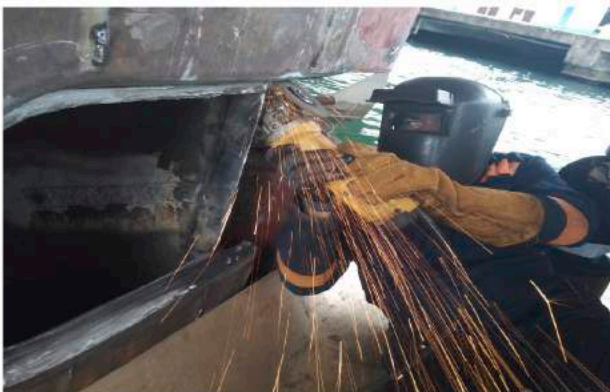
The rudder accesses were opened and immediately the gauging process of cracks started, as well as the cropping of the damaged shell on the opposite side of the rudder. The NDT technicians remained on site during the repairs to perform ultrasonic test on all rounds of welds, as well as MPI tests on the plates, to detect invisible cracks throughout the complete process, along with the class surveyor. TISA welders successfully passed all the inspections despite extremely difficult welding conditions and access.
