TALLERES INDUSTRIALES, S.A.

24/7 SHIP REPAIRS AND MARINE SOLUTIONS ———

MAIN FEATURES

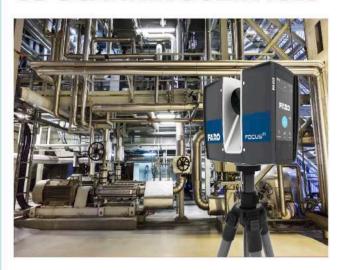
Our new equipment creates accurate, complete, and photorealistic 3D representations of any environment or object in just a few minutes, and with a new software (AsBuilt), our engineers will have the capacity to create drawings of existing equipment, pipes, or structures.

Our New Laser scanning Focus L70 ships is easy to operate and offers built-in protection from dirt, dust, fog, and temperature (0 to 40°C).

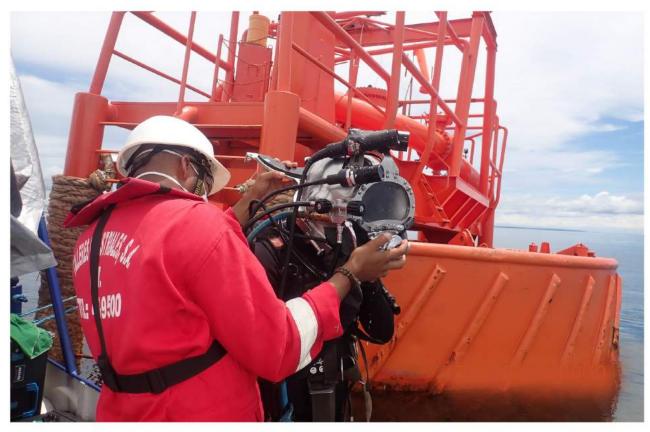
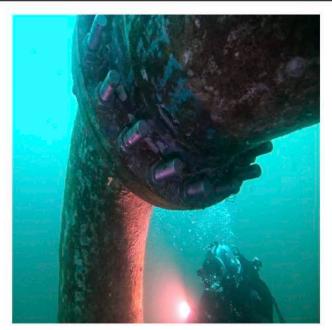
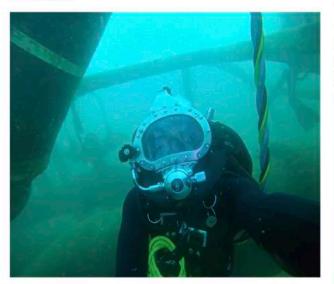
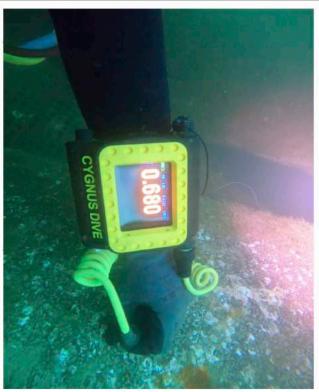
Besides our daily attendances on ship husbandry in the Americas, Talleres diving division also works on power plants, hydropower infrastructures, mining industry, and offshore platforms upon request. On this occasion we were contacted by a long-term client to perform a detailed underwater survey on the two Buoy Mooring System of the Trans-Isthmian Pipeline at Chiriqui Grande Oil Storage Terminal.

Our Certified Commercial Divers following all safety protocols performed underwater ultrasonic thickness gauging of pipes as well as underwater magnetic particles destructive tests on specific points. They also performed surveys on the hoses, couplings, and flanges of the pipeline system.

All connecting bolts were inspected one by one to make sure all were properly tightened and secured. Job was completed in two days and a full report was submitted to the customer.

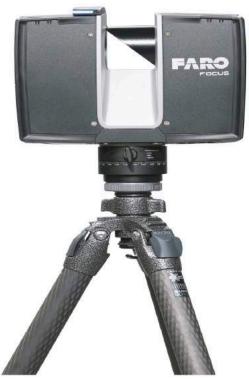
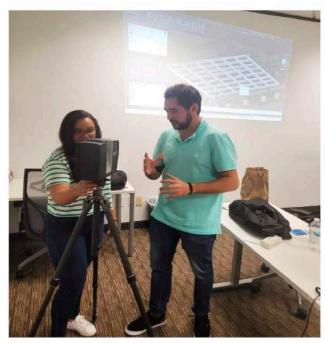
Last month, 3 of our young engineers visited FAROS facilities in Houston to train on the use of our new investment - FARO FOCUS 70 laser scanner. Our new equipment works by sending an invisible laser beam into a rotating mirror that deflects the laser beam around the environment being scanned. With 360° range and +/-0.2mm accuracy at 10m, the laser scanner captures full coordinate information for a cloud of points on every surface the laser hits. It also documents each scan location with color images. By taking multiple scans from different locations the combined data can be a useful reference for large objects or complete areas with multiple rooms. This scanning process will change how you think about ship checks and 3D documentation. Here are just a few ways we are using this technology:

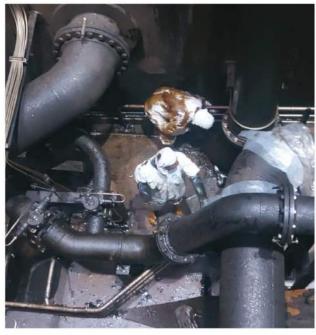
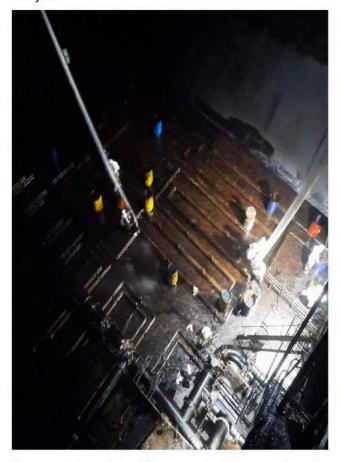
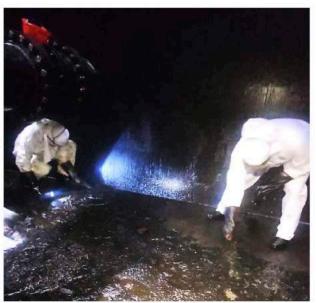
We accomplished this primary task by placing our industrial ventilator on the deck and installing plastic ducts to each of the tanks. Once the tanks were properly ventilated, our safety officer, along with a certified marine chemist, took oxygen and gas level readings and gave us a green light to start the job.

Our on-duty safety officer must always continue to monitor the tank with a portable multi-gas detector and take note of every worker who enters and exits the tanks.

The cleaning job required two 12 hour shifts every twenty-four hours. The team worked on the bottom of the tanks with shovels and action hoes to push and pull approximately one foot height of heavy sediments into open 55-gallon drums.

The other areas which required special cleaning were the tank bell mouth and the surrounding bulkheads. The team was also instructed to clean the heating coil pipe of all residues. Both vessel owners required us to complete the job as quickly and safely as possible, to be able to reach its next charter destination for new cargo. TISA was able to accomplish the task one day before the planned schedule. The tank cleaning team is always ready to perform this difficult job with the highest of safety standards and supervision.

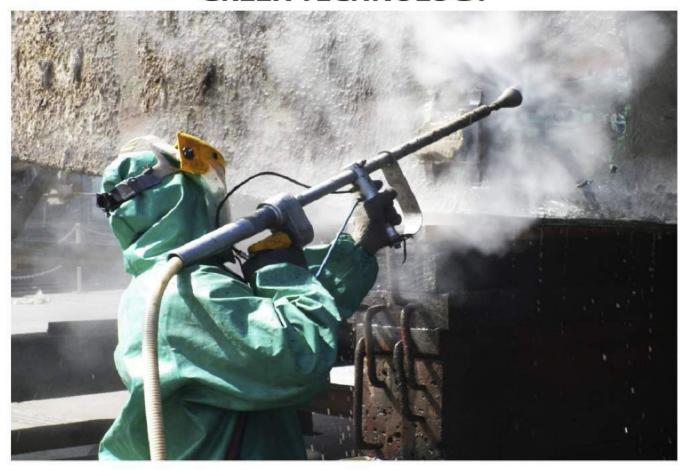
Waterblasting is a solution that allows the integrity of the surface by high-pressure water cleaning.

The use of high-pressure water blasting, for surface preparation and surface cleaning, can eliminate rust, old coatings, product residue or even damaged concrete prior to re-pouring. In addition, it ensures proper adhesion of the coating to the original surface.

Talleres Industriales has invested in state of the art HPWJ X-Series diesel water blasters with working pressures from 5,000 to 40,000 psi (350 to 2750) are easy to mobilize to terminals and onboard vessels at the Cristobal and Balboa anchorages. We can also use this equipment for pipes and cargo tank cleaning.

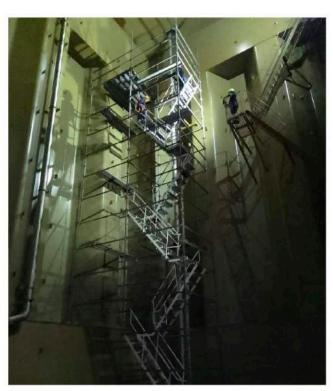
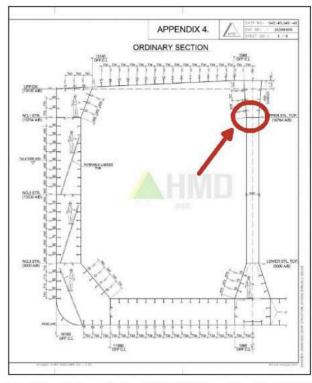
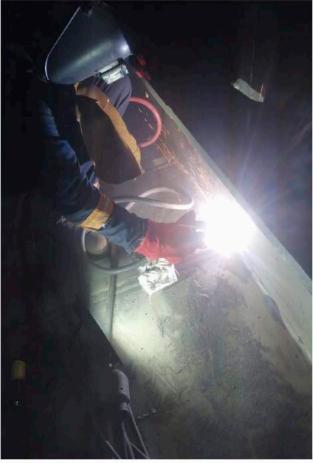
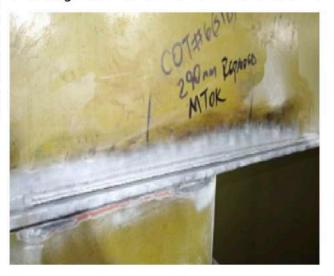
Last month, we were contacted by a ship manager of a Panamax chemical tanker requesting our support to perform repairs in the Void Space No 1 and 2 / Bottom area of the upper stool, from COT No 2, 5, 6 where some areas of the welding seams have been observed with defects.

NDT team was arranged to perform dye check to all suspected areas finding a total of 11 cracks on welding seams that needed urgent attention. Crack repairs included gauging, edge preparation, and full-penetration weld.

After the entire crack was repaired, it was inspected with the use of ultrasonic equipment to class satisfaction. Upon completion of the welding jobs, the cargo tank coating was restored following Paint Manufacturer recommendations.

The most critical part was the logistics to set up the welding team to perform the job on a safe manner. Talleres team erected 9 scaffolding towers on 3 cargo tanks at each position of the suspected areas and ensure that while building up the scaffoldings the tank coating was not damaged.
