TALLERES INDUSTRIALES, S.A.

24/7 SHIP REPAIRS AND MARINE SOLUTIONS —

TRANSFER OF OVERSIZED CARGO TO THE CARIBBEAN

GEARED BULKER STRIKES AN STS CRANE AT PORT MOIN, COSTA RICA

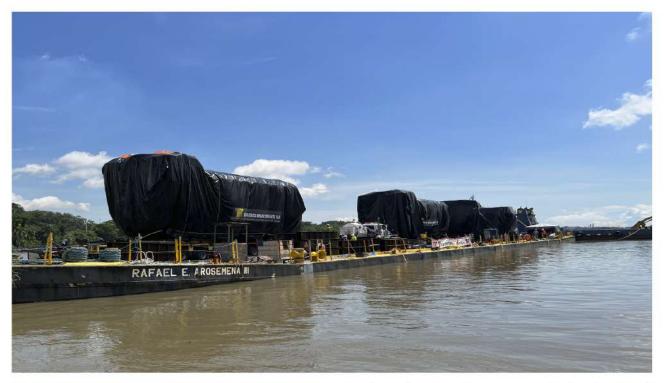
The barge was placed at berth in order to first lower the generators and transformers with the assistance of the gantry crane and then load 20 units of 20ft containers with accessories and auxiliary systems of the engines.

Once all items were onboard, we started the securing process. All containers were lashed properly using chains and turnbuckles. In addition, some stoppers were placed in the corners of each container and on the lateral sides. After the generators were lowered, we re-secured them using chains and turnbuckles with a capacity which doubled the weight of the items.

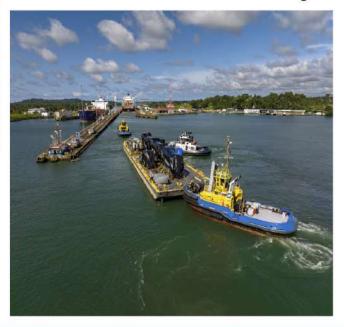
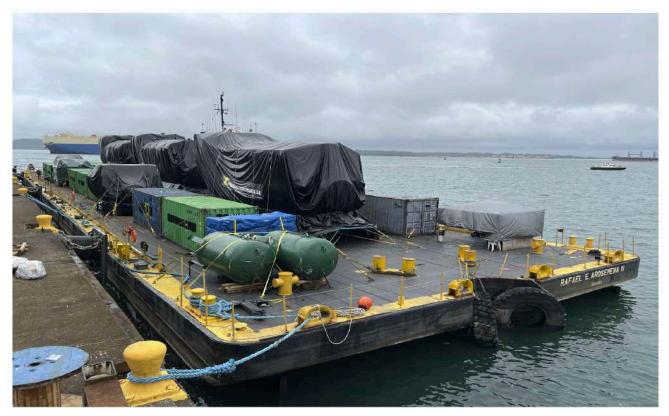
On the other hand, we proceeded to finish all welding jobs on the base of the three engines, which involved transversal and lateral stoppers between each one of the beams and between the transversal beams and the base of the engine.

After completion of all jobs a Marine Warranty Surveyor, who was hired by our customer, inspected the cargo, and recommended some additional jobs to ensure full safety of the cargo. These recommendations were completed in less than 48 hours. We also performed non-destructive testing on all our D-rings which were welded on Deck for chain's securing. Finally, we removed all our tools and equipment and assisted in the undocking of the barge before it sailed to the Caribbean.

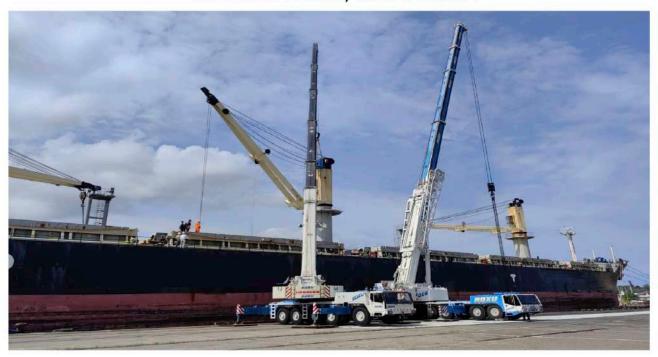
A geared bulker struck an STS gantry crane at Port Moin, Costa Rica two months ago, damaging both gantry and the ship's cranes. The almost 35000-ton Bulk Carrier's three cranes were all elevated while she moved down the quay.

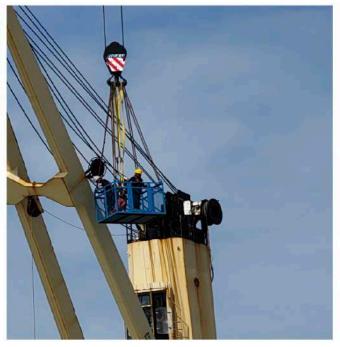
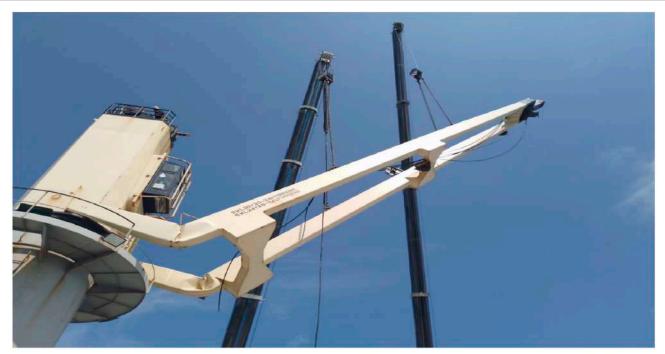
The ship's cranes cleared the first STS gantry, which was raised, but made hard contact with the second, which was still in the lowered position. As the bow passed under the gantry, the first crane's boom was forced downward, but managed to slip by. The second shipboard crane was oriented facing the gantry and got caught, forcing its boom upwards and twisting it to port. The STS gantry swayed with the impact but did not collapse, and the ship came to a halt. Talleres mobilized engineers, riggers, and mechanics from our

headquarters in Panama to Costa Rica to urgently assist vessel in order to remove the damaged crane from position and secure the same to deck to allow vessel to depart to her next port. Talleres organized in record time all the logistics to make this job a reality, well done project with outstanding results. Crane contractors, local agents, and local logistic support in Costa Rica worked along with our engineers and riggers and managed to remove and secure the jib working 24/7. At Talleres, we are always ready to mobilize our team and give effective solutions to your vessels at any country in America.

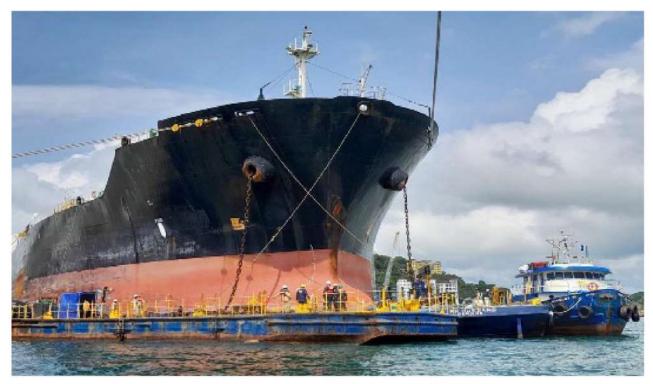
24/7 ANCHOR CHAIN REPAIRS UNDER CERTIFIED PROCEDURES

Here in Talleres we have certified procedures and class approved welders to perform stud link repairs at anchorage and alongside berth. These types of repairs are very common nowadays and Panama is a perfect place to take care of that problem. We are full equipped with deck barges, skilled labor, and with an NDT department to perform test of welds. We are available 24/7.

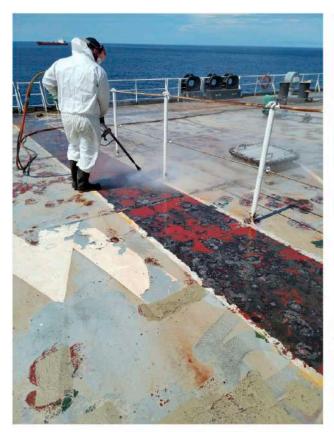
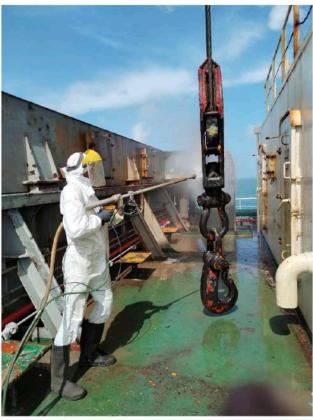
SHIP'S DECK DERUSTING AND PAINTING

It is no surprise that the pandemic period had an impact worldwide and made many jobs decrease or even stop. For us, water blasting jobs were halted during this time. Now, we count with a Water-Blaster able to reach 40,000 psi which is suitable for preventive and corrective deck maintenance. Customers are slowly requesting more and more of these types of jobs because they realize all the benefits that an appropriate maintenance provides to their vessels. We have done two back-to-back jobs of this caliber recently.

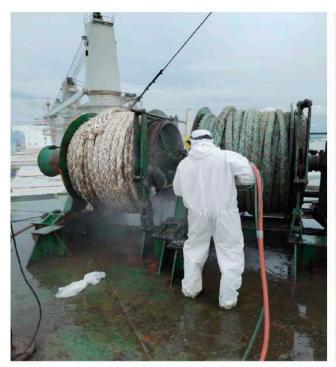
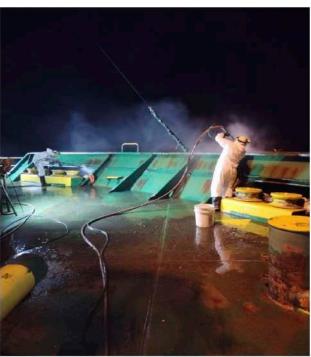
We load the machine in our supply boats or deck barge and then with ship's crane we place it in a strategic position to perform the required job. We mainly perform surface preparation on winches, cargo hold hatch covers, main deck, and other deck machineries. This enables us to perform consequent painting jobs in the best possible way!
