M S MAGAZINE

AFLOAT AMAZING RUDDER REPAIRS

BULBOUS BOW
PLASTIC SURGERY
PAGES 9 - 11

AFLOAT RUDDER REPAIRS

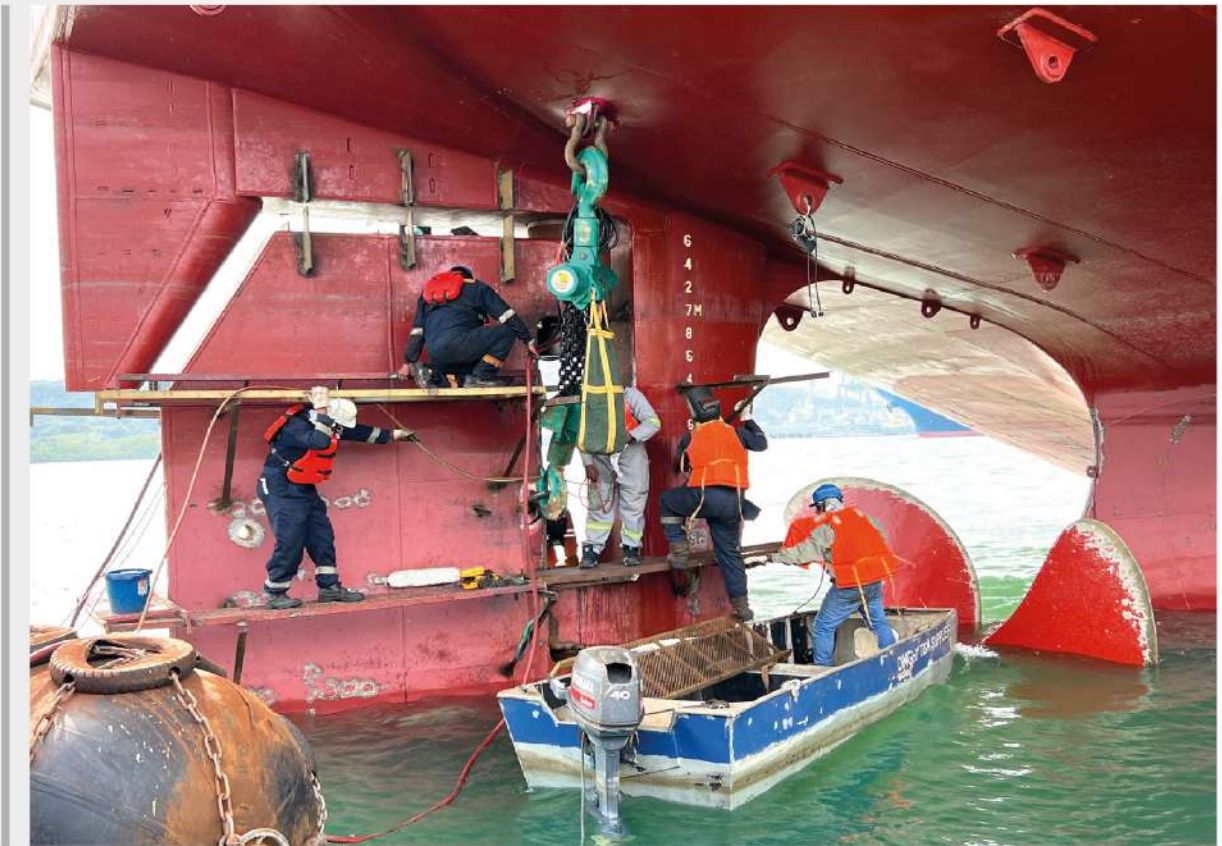
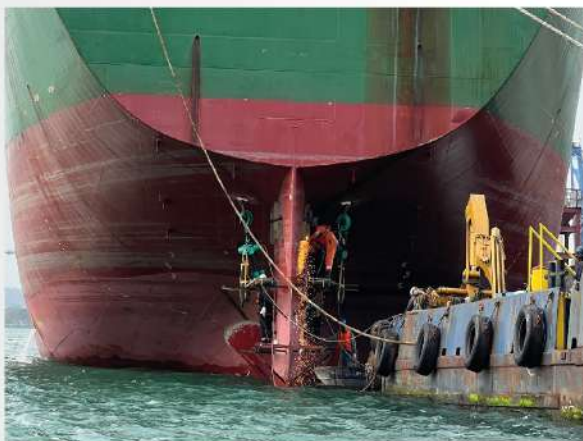
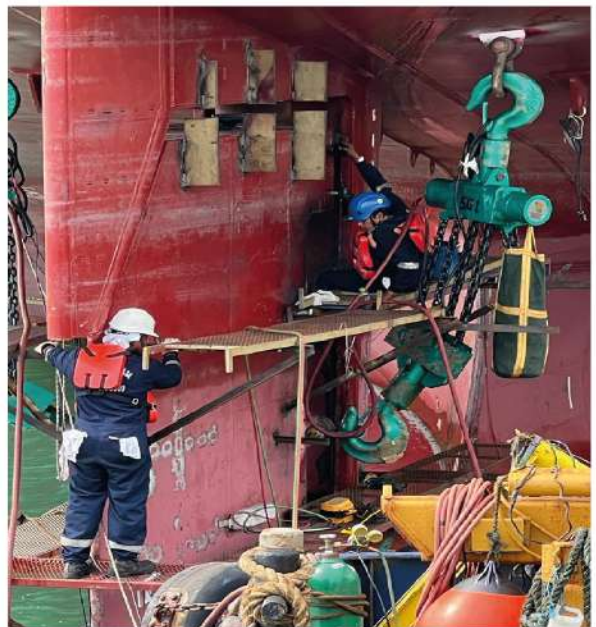
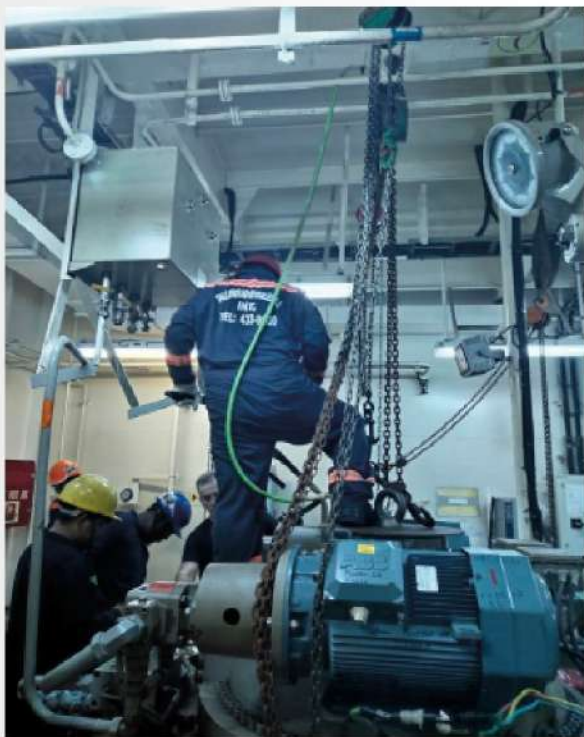
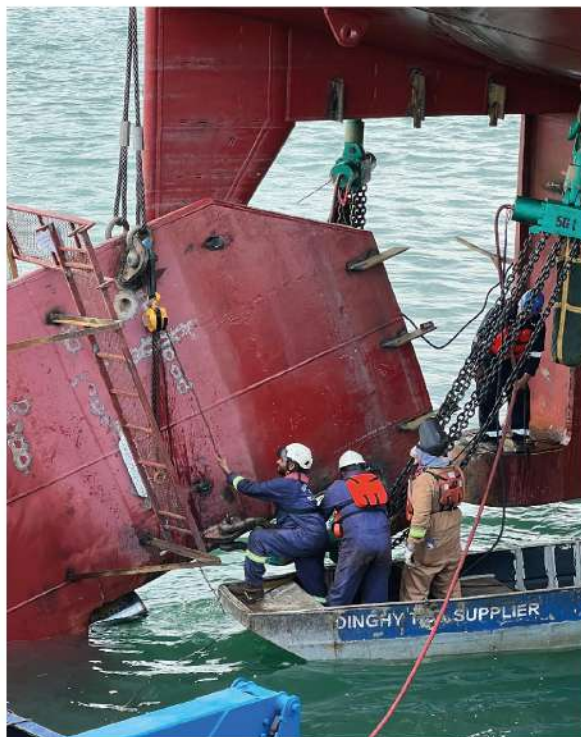
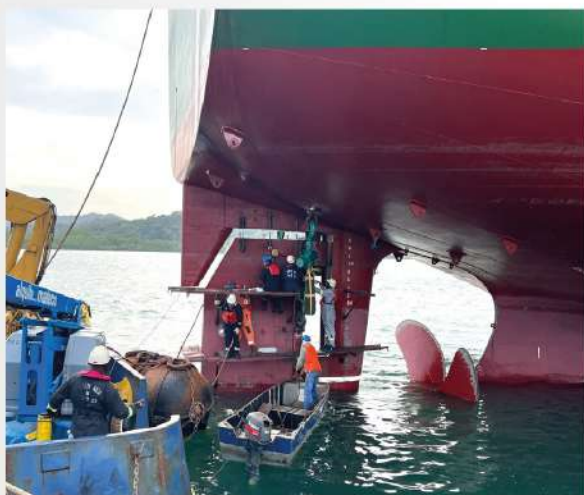
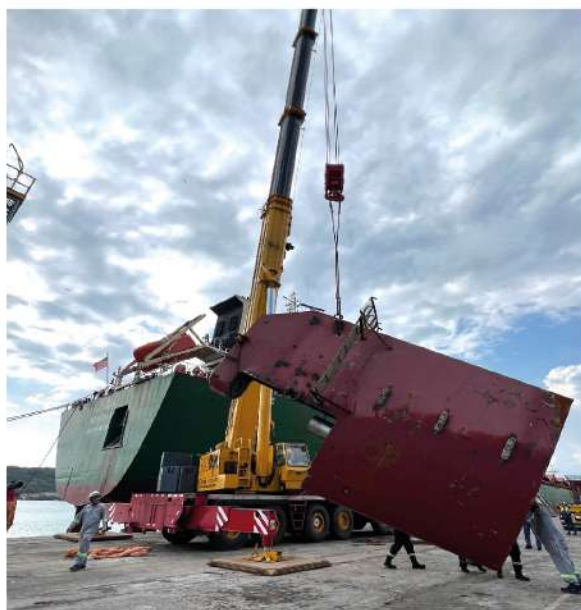
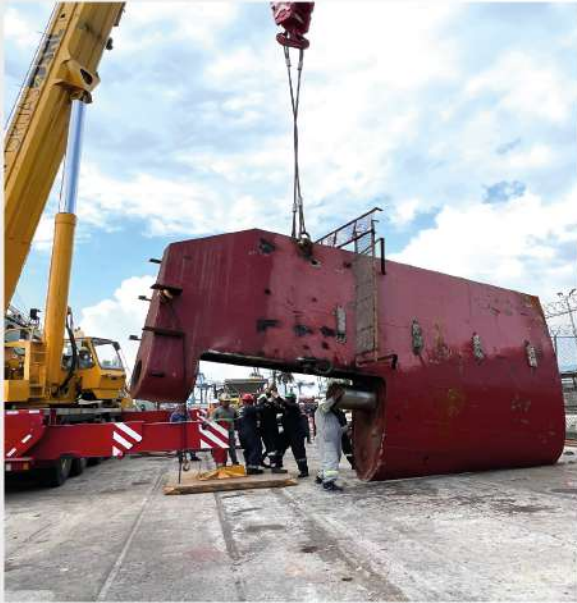
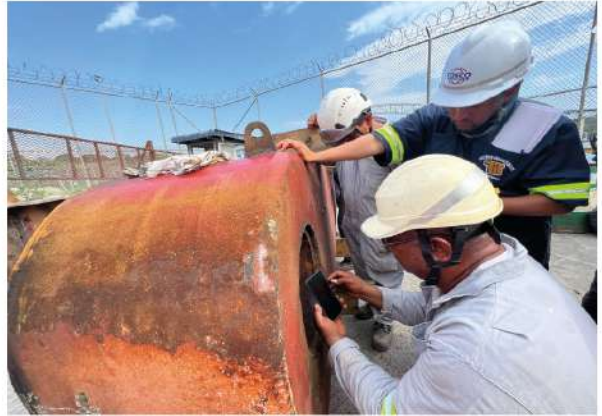
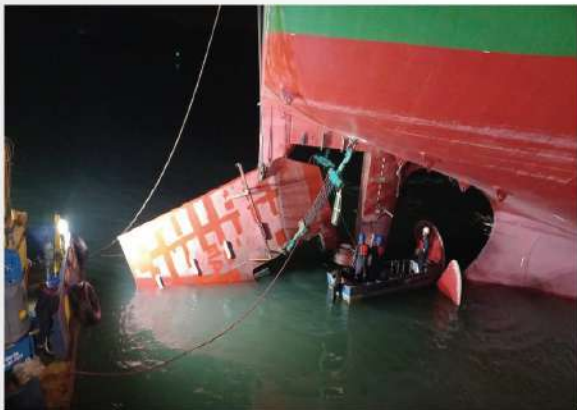
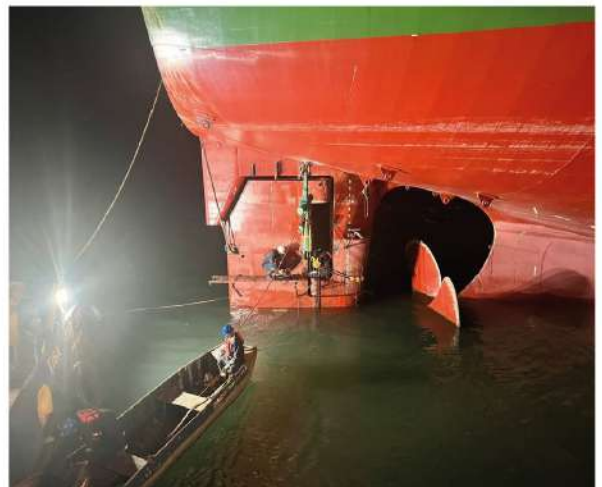
In this case a 30,000 DWT bulk carrier trusted us with their rudder problems and diverted the vessel from South America to Panama for permanent repairs to her rudder.

The scope of this out of the box project involved removal of rudder blade afloat to replace the rudder stock bush and the lower pintle bush. To achieve this task, first, we had to fit and weld pad eyes to the rudder and vessel hull to secure the rudder blade with our special 50-ton pneumatic chain falls.

Then we opened the access to the rudder stock nut and rudder pintle nut to release hydraulically the rudder stock from the rudder blade and remove the nut. Inside the engine room, another team of mechanics furnished to lift the tiller head and rudder stock inside the steering room and dismantle the rotor from the rudder stock.

Finally, outside the delicate removal of the rudder blade, maneuvering to the working site took place successfully. Once at the yard, we removed the lower pintle nut from the rudder. Rudder pintle was machined in our industrial lathe and skimmed as per makers instructions.

We then replaced the lower pintle and upper rudder stock bushing according to the bushing approved procedures. After all workshop jobs were completed, then the installation maneuvering started. .

In this final stage, our engineers proceeded to connect the rudder blade with the rudder stock by hydraulic means meeting the pushup requirement. Rotor was connected to the rudder stock and the tiller head was connected to its foundation as well as other systems required. Outside fitters proceeded to install, fit, and weld cover plates. Finally, our NDT team performed all the tests required by class. We feel proud to be the helping hand of shipowners around the world in ongoing difficult and stressful situations like this one.

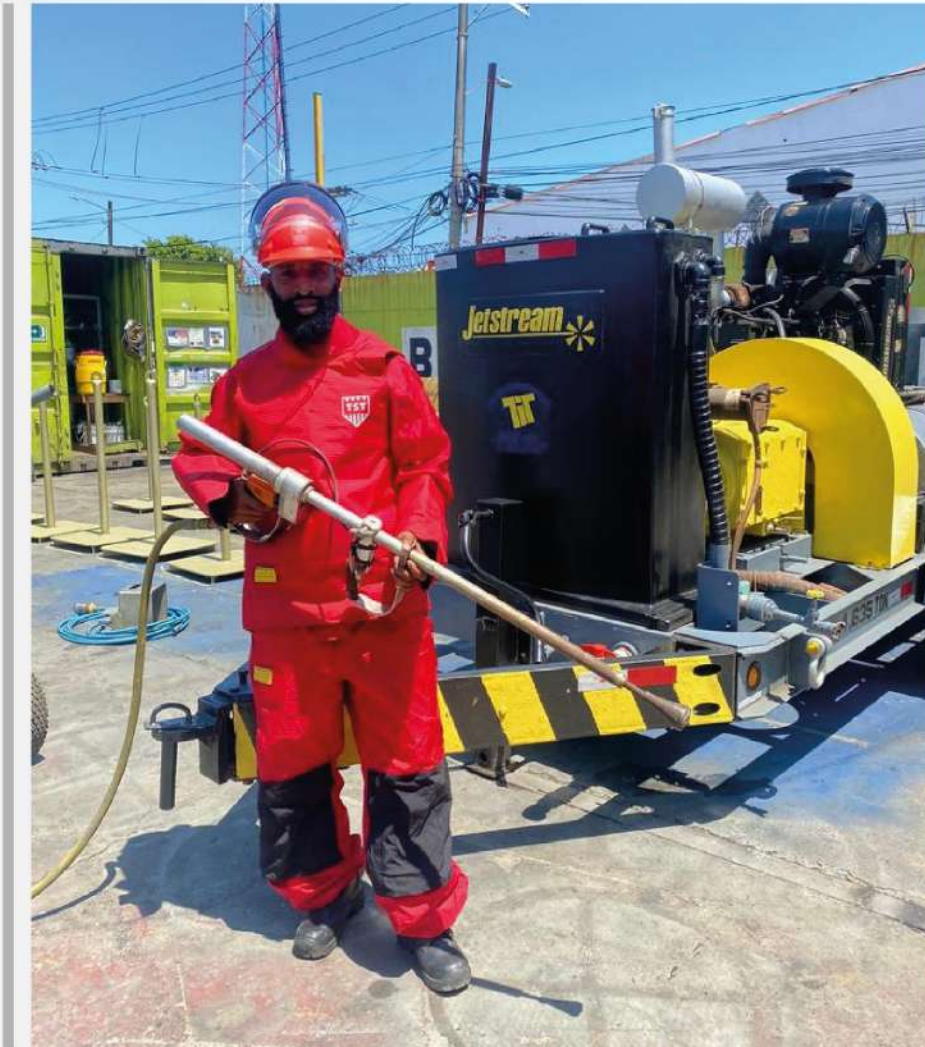
Water blasting is a solution that allows to maintain integrity of the surface by high-pressure water cleaning. The use of high-pressure water blasting, for surface preparation and surface cleaning can eliminate rust, old coatings, product residues, and even damaged concrete prior to re-pouring. In addition, it ensures proper adhesion of the new coating to the original surface.

Talleres Industriales has invested in state-of-the-art HPWJ X-Series diesel water blasters with working pressures from 5,000 to 40,000 psi (350 to 2757 bars). This unit is easy to mobilize to terminals and onboard vessels at either Cristobal or Balboa Anchorages. The range of use also includes pipes and cargo tanks cleaning.

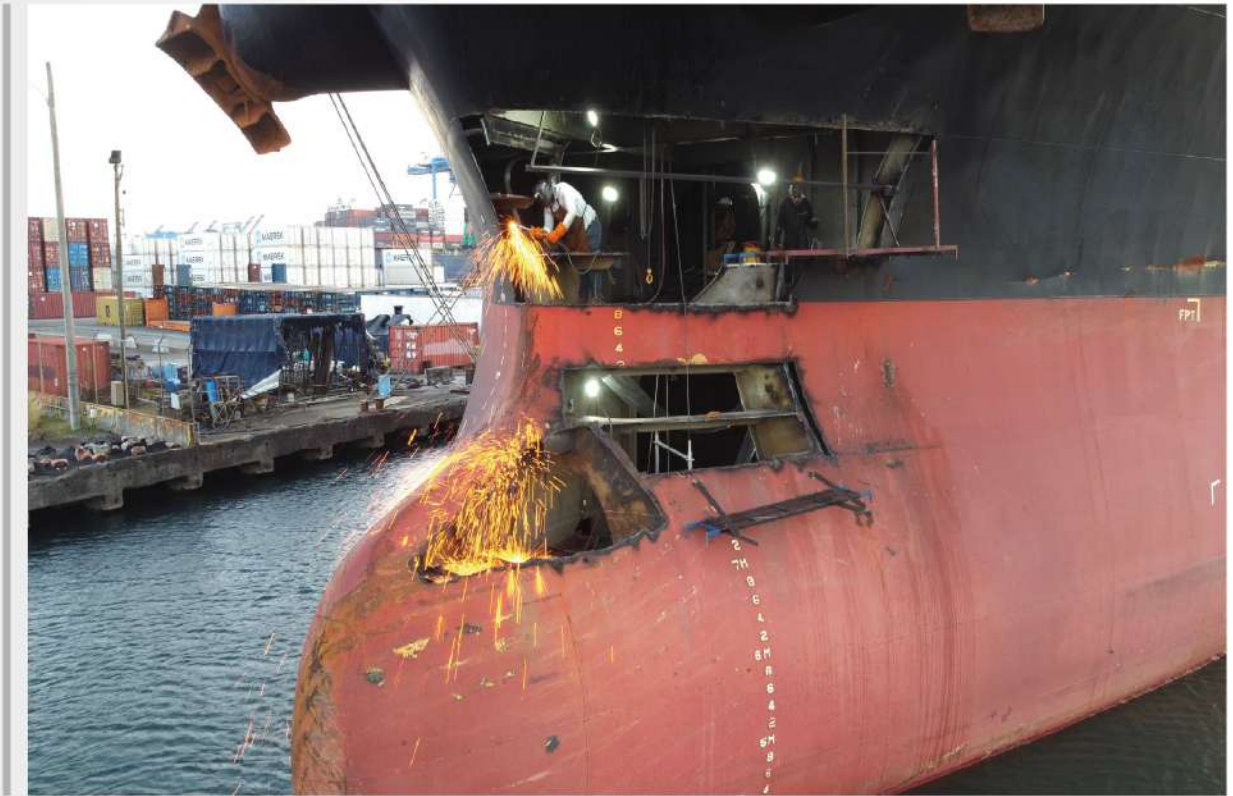
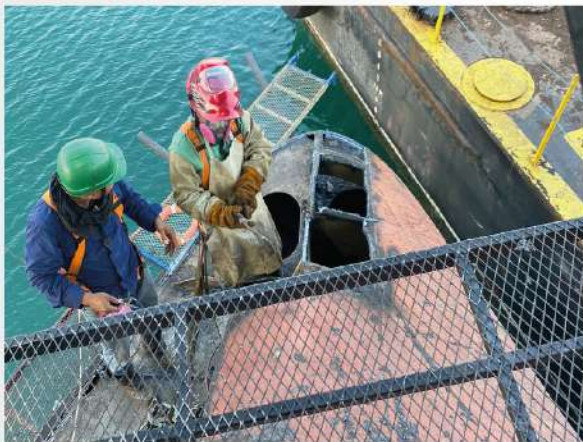
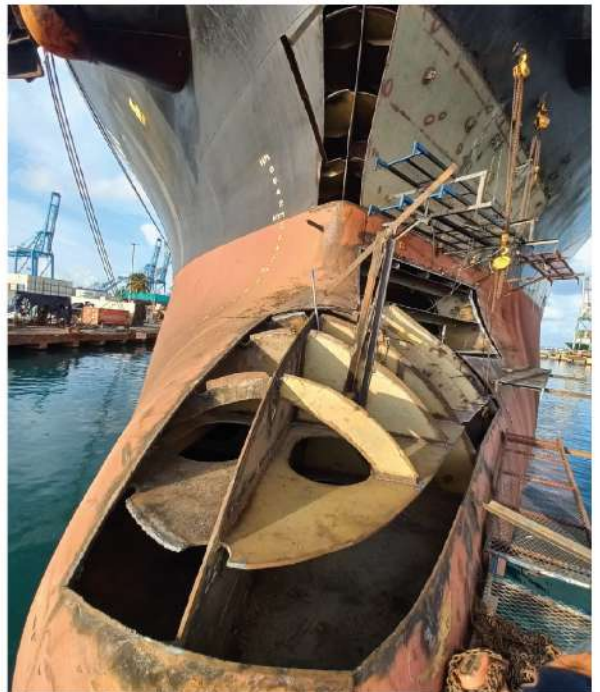
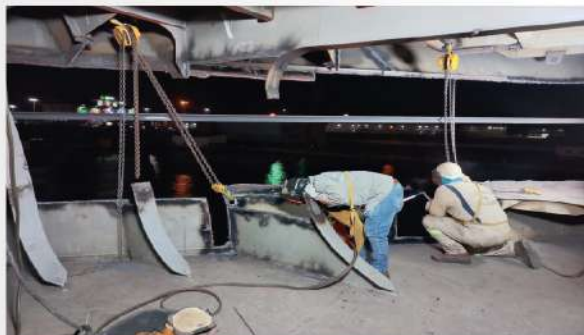
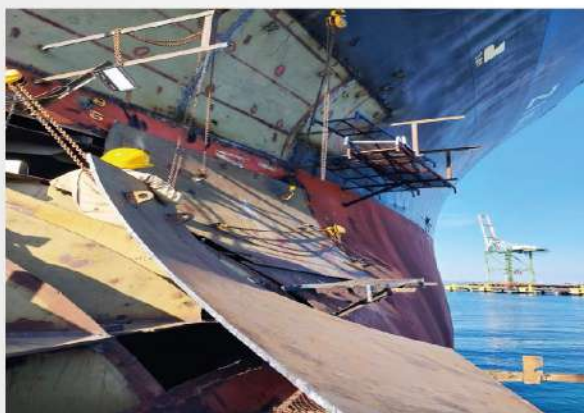
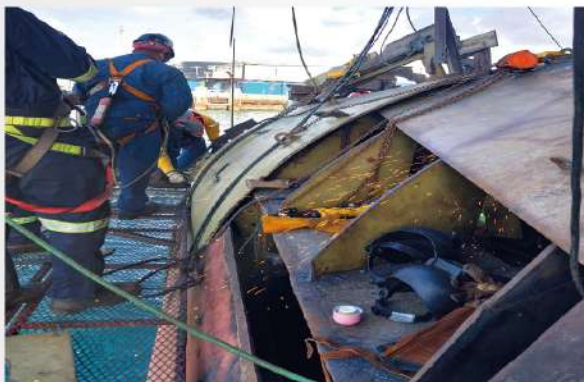
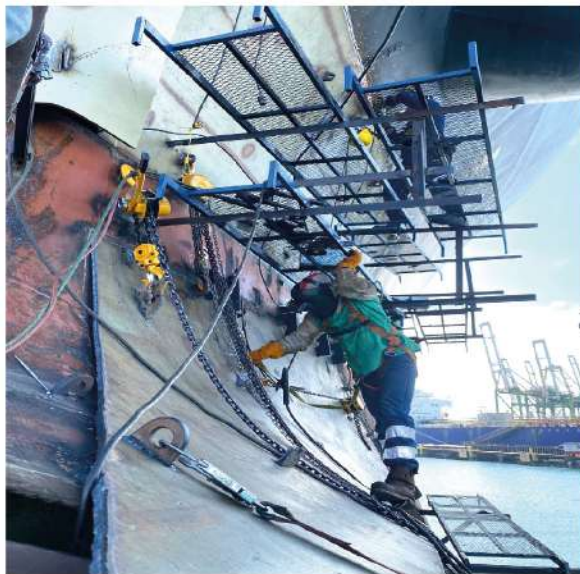
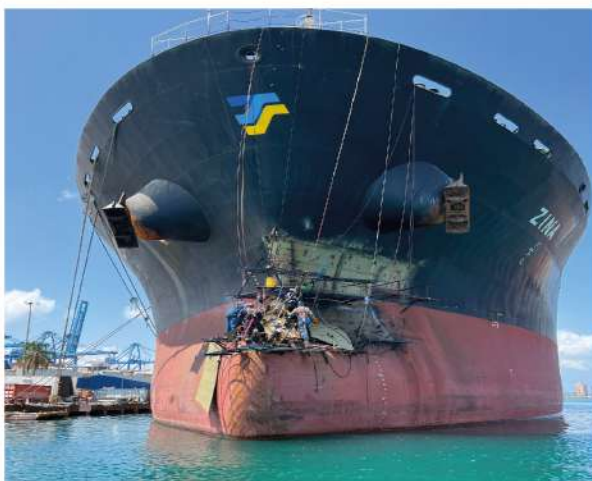
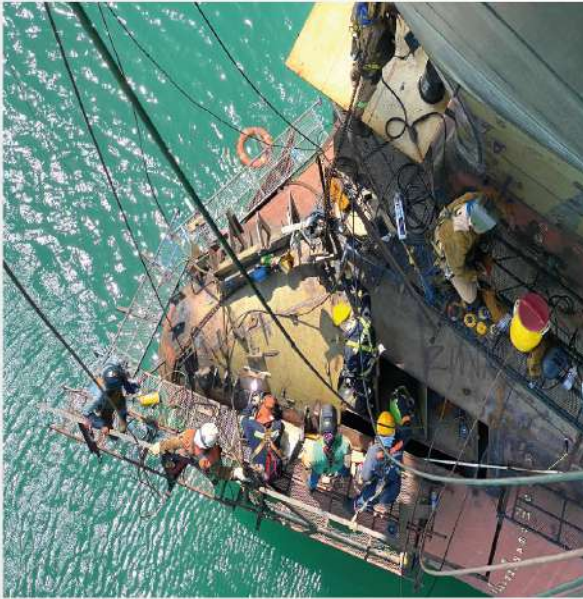
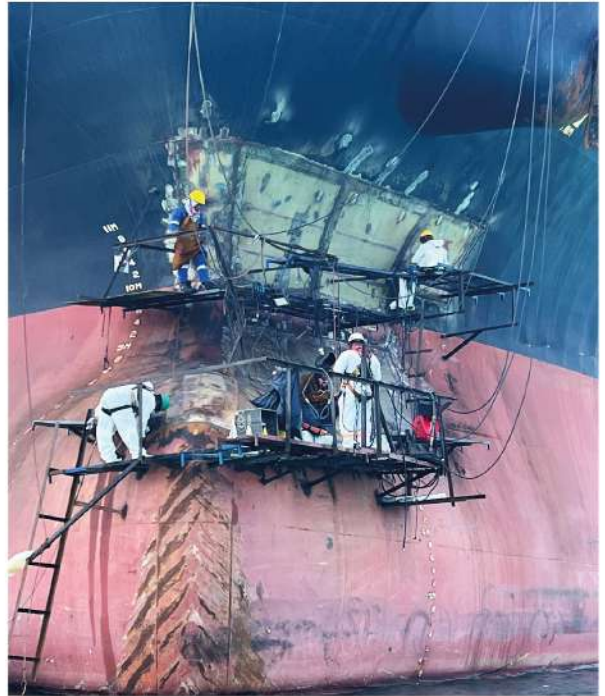
Bulbous bow is one of the most difficult structures to repair and renew on a ship due to her formed, complex construction, and plating thickness. Earlier this year a vessel suffered major damage on her bow structure due to collision with a floating barge in Argentina, South America.

Vessel had damage in the fore peak tank, stem, and bulbous bow. All sections with single and double shapes. Owners approached Talleres in Panama and after receiving our technical advice and reviewing our repair plan they diverted 5800 nautical miles to perform permanent repairs with our company at the Atlantic side of the Panama Canal.

We then realized the precision of the bending and shaping of plates that had to be performed which were going to be critical for the outcome of this project. The damage was considerable at the bulbous bow, stem area, and fore peak tank. These were made of high tensile steel plate and totaling close to 8 tons of steel. Port side hull plating was fractured and deformed in forward void space and all internal members consisting of side longitudinal, web frames, stiffeners, brackets, and collision bulkhead had to be renewed. All steel profiles were manufactured in our workshop and class approved welders and fitters installed them around the clock.

Upon arrival, the vessel was docked at the repair berth and immediately cropping of damaged sections started.

Upon completion pressure and NDT test was performed to all welds. This project was very challenging, and we had to go the extra mile to avoid our good clients' further delays and make sure they got back at sea to accomplish their commercial commitments.

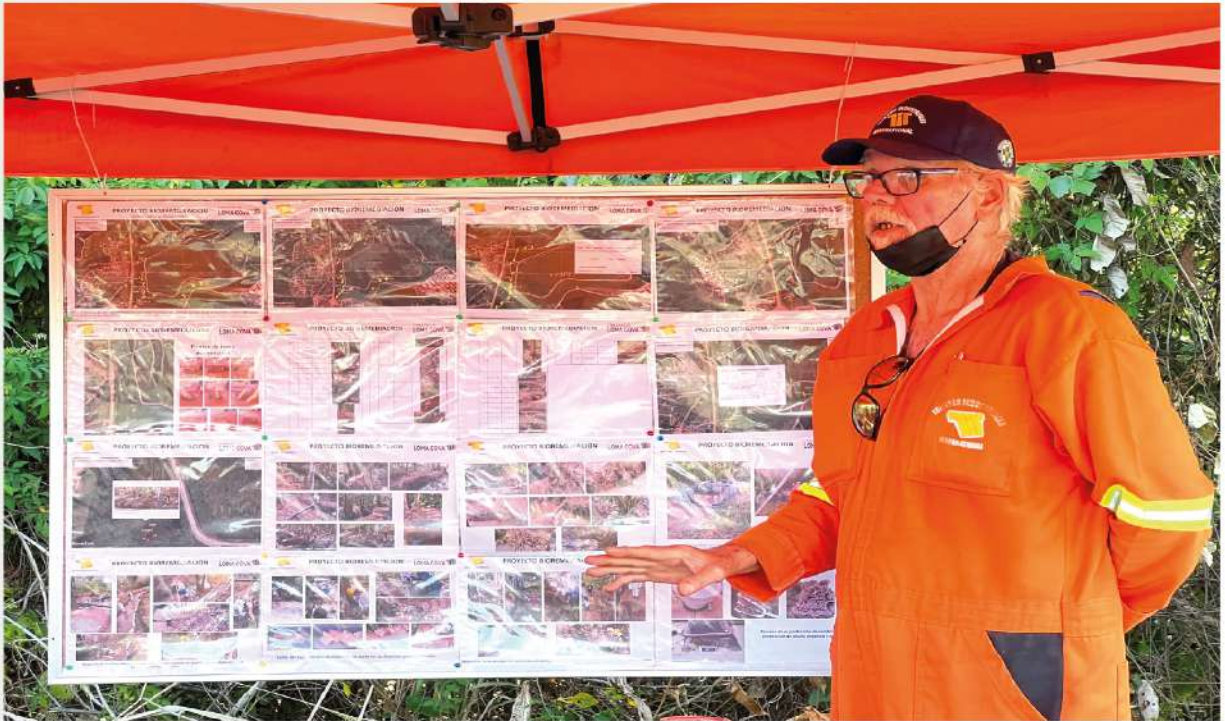
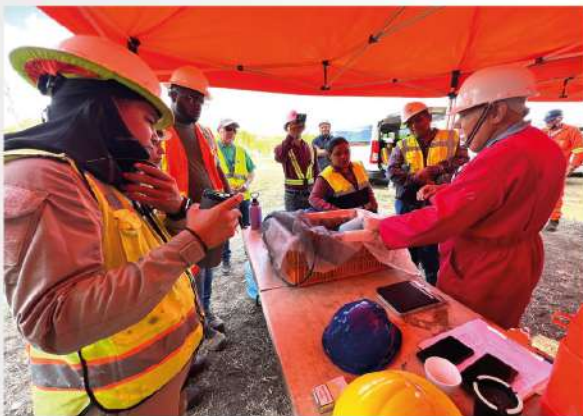
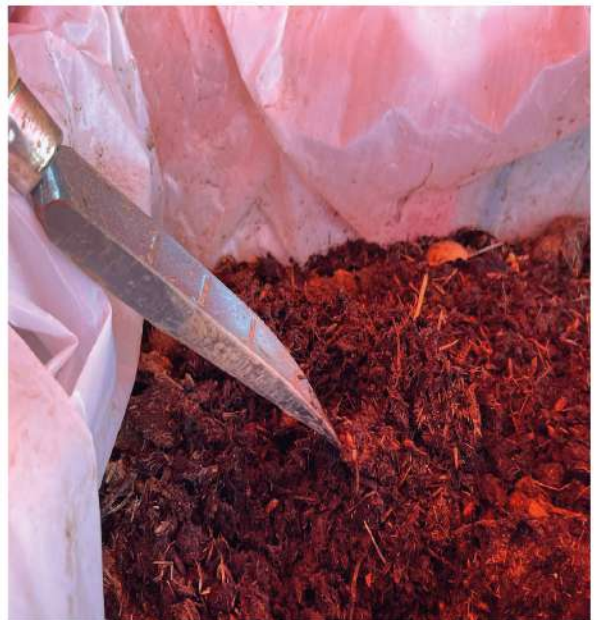
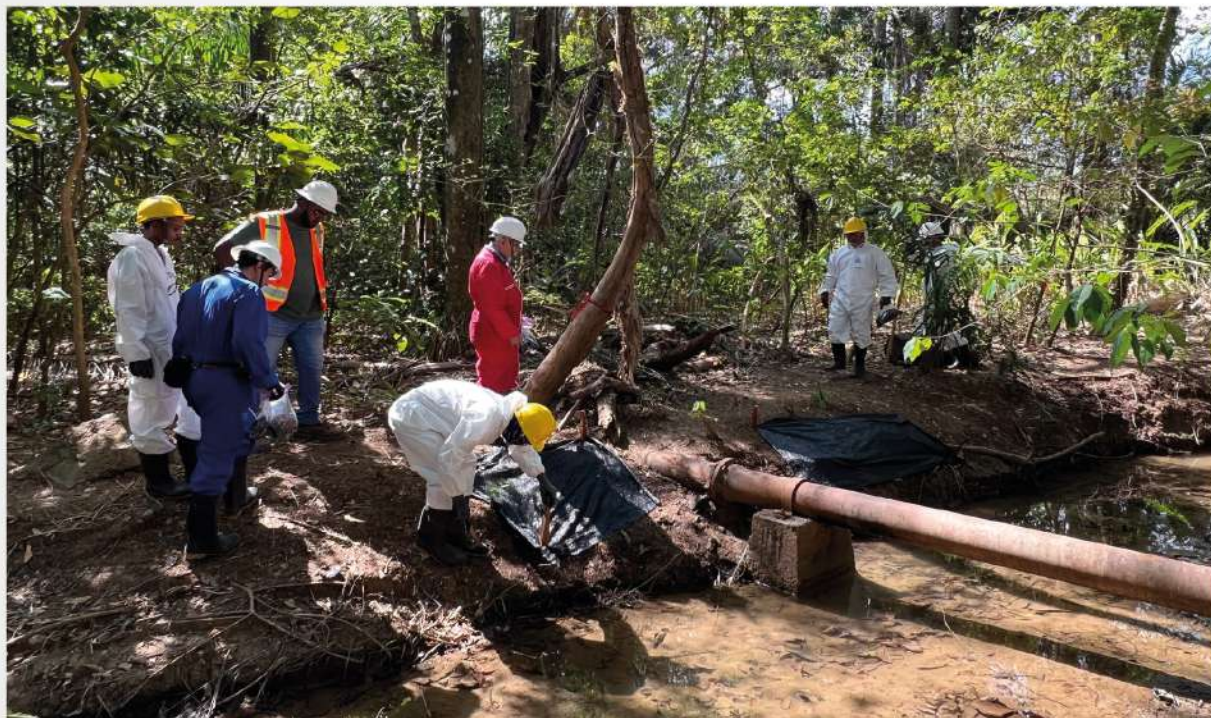
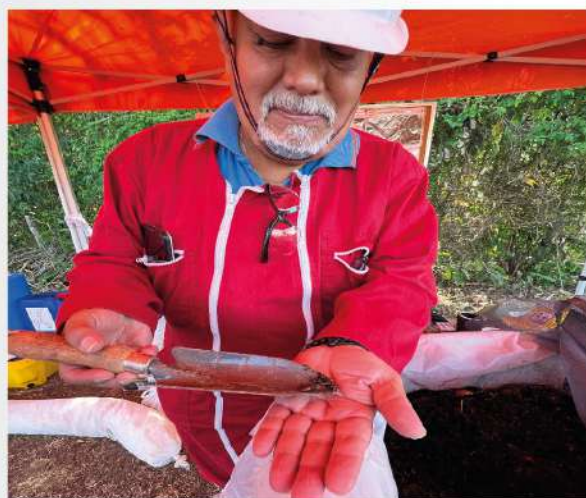
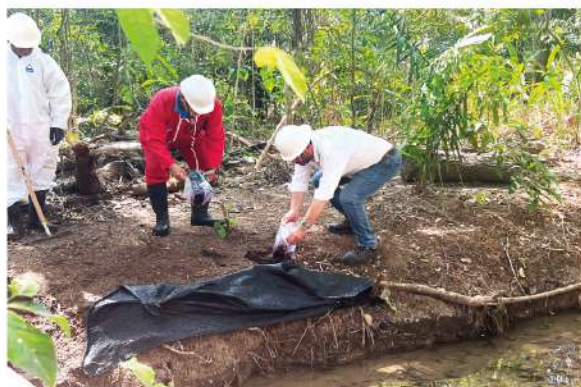
Between February 13 and April 6 of this year, Talleres Industriales and its Pollution Control Division implemented an on-site bioremediation strategy in a wooded lot in Rousseau area, considered a protection zone of the Panama Canal. The purpose of this project was to restore to their original conditions the soils impacted by a hydrocarbon spill.

The contaminated area was intervened through a multi-step process that included the extraction of stained organic material, application of biodegradable surfactant solution and nutrient solution to increase the bio stimulation of microorganisms and bacteria, ending with the application of an organic fertilizer with earthworms raised in Panama, improving soil biodegradation conditions.

The result of the applied strategy was successful since at the end of the first month, the levels of Total Hydrocarbons have been reduced, on average, by 63.23%. Levels will continue to decline over time as densities of bacteria and microorganisms in soils will increase. .
