TALLERES INDUSTRIALES, S.A.

MAGAZINE 10th Edition

Permanent Repairs After a Collision Between a Submarine and a Container Vessel

Anchor Chain Repairs on a Neopanamax Tanker at Balboa Anchorage

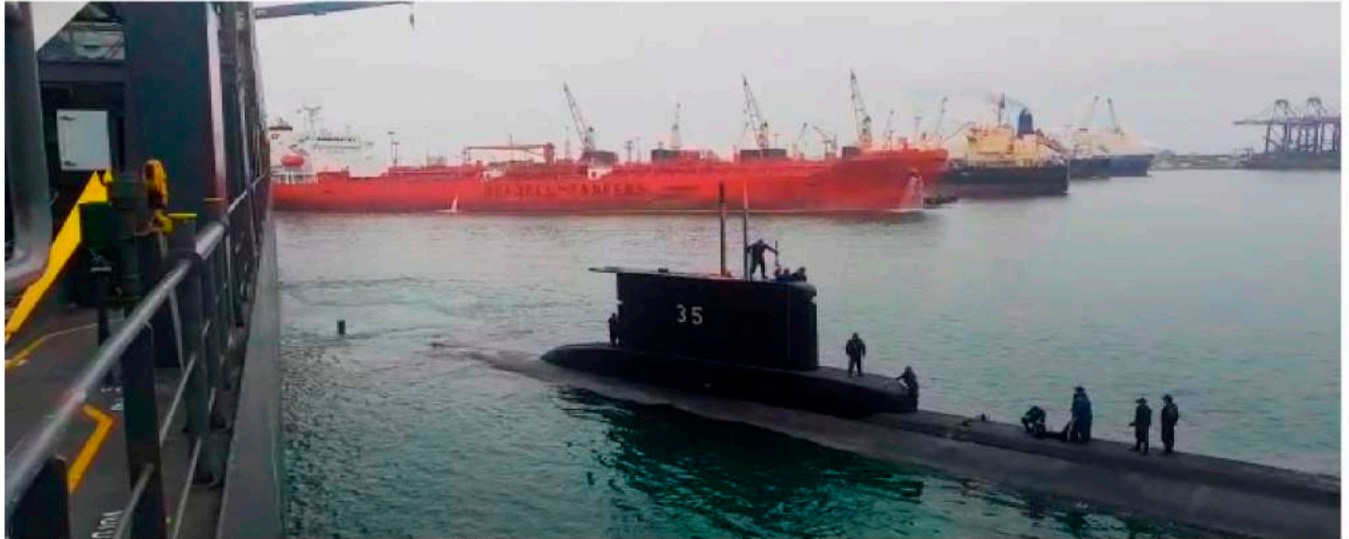
Earlier this month, a 3000 tons DWT container ship suffered damages after a collision with a Navy submarine in Callao, Peru. The Submarine collision affected the mid ship area structures causing a rupture on the side shell plate that flooded the compartment. The affected steel structure was in the way of her starboard water ballast tank No. 4, and the same was approximately 700 mm long x 500 mm width indented.

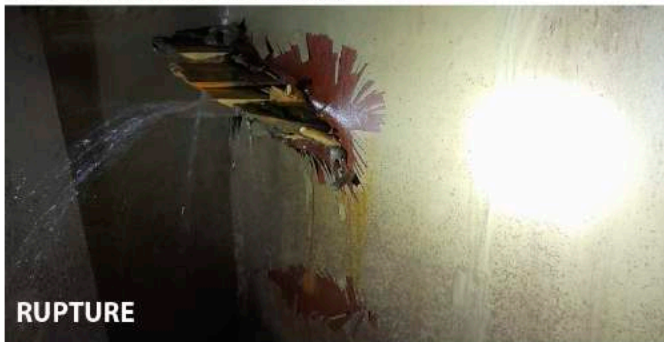
RUPTURE

Vessel arrived at Balboa terminal for discharge and immediately the rupture was sealed with wooden wedges and marine epoxy putty to allow internal inspection with the attending class surveyor and together with the insurance. Once at the anchorage, the damaged section was sealed with our custom-made cofferdam and the internal 15 mm grade A steel plate was cropped and renewed by an approved class procedure for full penetration welding. The job was completed as per satisfaction and within the time frame given to the owners to allow the vessel sail on time to her next port without a condition of class. Talleres Industriales, S.A. one more time reaffirms its commitment with our clients to provide the best services with the highest safety and quality standards.

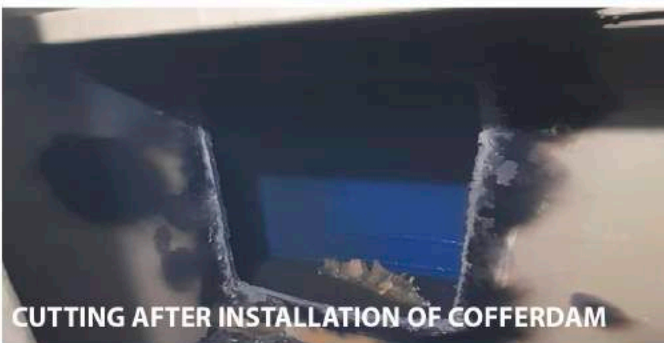
CUTTING AFTER INSTALLATION OF COFFERDAM

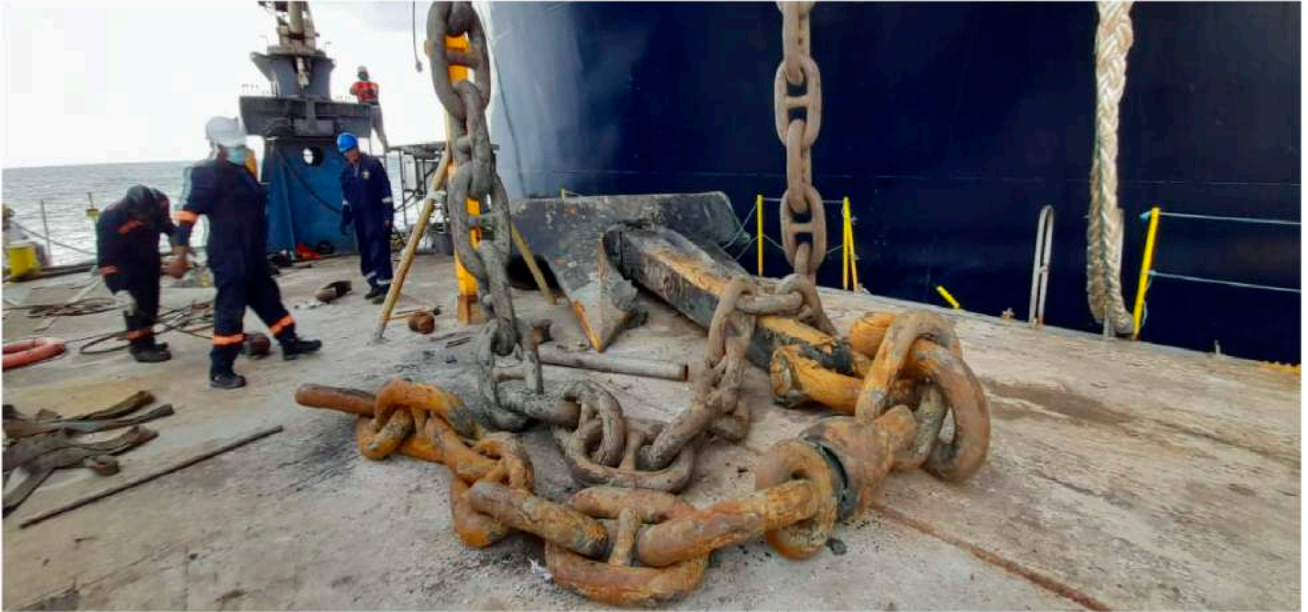
We received a phone call at 0500 morning time from ship agent that they had an urgent request! A chemical tanker with a gross tonnage of 156,237 and an overall length of 336 meters was stuck at Balboa anchorage since her anchor got entangled and could not depart to her next destination. Master reported that anchor chain fouled in very strange condition which has never been witnessed by anyone onboard. Efforts were made by crew to clear the fouled chain by lowering and picking up. Also, chain was stretched to some level by using engines as it is the normal practice for anchoring. However, efforts were not successful, so Talleres' help was needed.

Two hours after the initial contact, our crew of engineers, fitters, and riggers along with supply boat and crane barge, departed from our base to support and solve the complex and unique issue. The anchor and tangled chain were lowered to the deck of the crane barge, chain was lifted and kenter schakle had to be removed to allow the unravel of the chain.

Once the chain was back to normal position, then a new kenter schakle was installed and pin welded with lead. Job was performed in record time allowing vessel to depart to her next destination without further delays. This response is a typical example of our business model, **"an emergency room of a hospital for ships"**
